Erosion Problems in Fluidized Bed Combustion (fbc) Power Plant Based on Lakhra Coal

Shaheen Aziz, Muhammad Ibrahim Pathan, Suhail Ahmed Soomro

Chemical Engineering Department, Mehran University of Engineering & Technology, Jamshoro. Pakistan

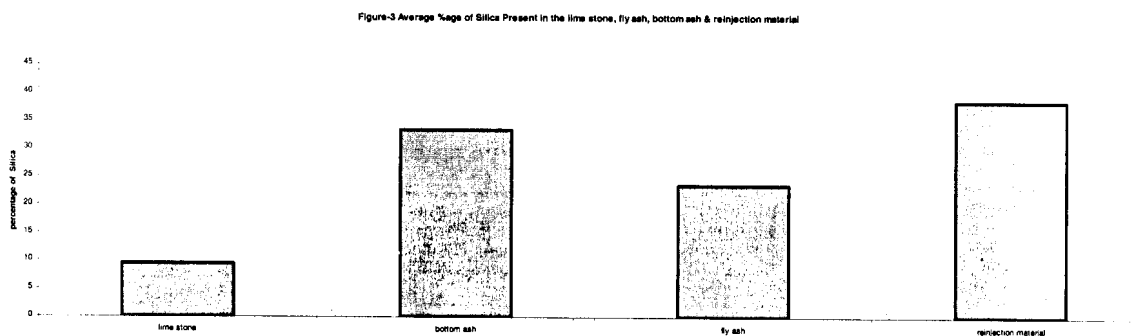
In Figure 3 the average data of silica present in limestone, bottom ash, fly ash and re-injection material have been presented. It can be observed that presence of silica in lime stone have created many problems. Huge amount has been paid for the purchase and crushing of this unwanted material, efficiency of the plant has been badly affected, and the whole plant has been damaged and consequently frequent shut down of the plant occurred, which resulted in heavy losses.

Fig 3. Average % Age Of Silica Present In Lime Stone, Fly Ash, Bottom & Reinjection Material
