# Pin-Hole Leakage in a Thick-Walled Flange

## Abstract

*Formation of a 'pin-hole' leading to gas leakage, in a thick-walled flange installed on a high-pressure gas line has been investigated to determine the nature and the cause of the leakage. The investigation was carried out by sectioning the flange along suitable planes and tracing the path of leakage with metallographic examination. It was learnt that the 1-inch dia steel flange had been made by forging followed by drilling a hole in the centre by conventional machining. The examination of metallographic sections revealed that during the forging of the component a forging fold had developed which was deep enough to just reach the location of central hole. The leakage through the fold, which took about 6 months to take a start, happened when the oxide entrapped in the fold had been eaten away by the acidic components of the gases.*

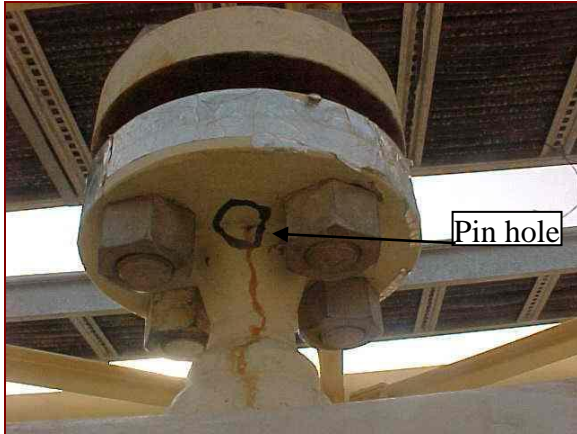
A photograph of the Flange taken before it was removed from its location of application was also provided along with the flange. This photograph, given in Figure 1, shows the exact location of the 'pin-hole'.

**Figure 1** Photograph of the leaked Flange taken before it was removed from its installation

As may be noted in Figure 1, the leakage marks on the outside of flange indicate that some kind of liquid (most likely the condensate in the pipeline) has been seeping through the pin-hole. Further, the microphotographs taken from the fold (given in Figure 5) show that the oxide scale inside the fold has been 'eaten away' at some places (Fig 5c), while it is still present at some places, especially in the narrower part of the fold (Fig 5b).

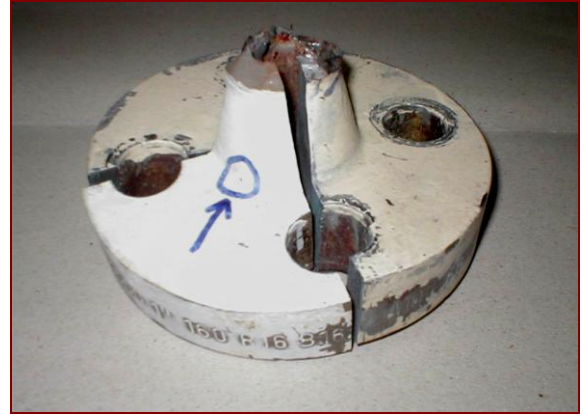
Since the visual examination with the help of a magnifier as well as boroscope did not reveal any clue about the pin-hole, it was decided to section the component along some suitable planes so as to be able to look at the inside of the bore, without disturbing the region around the 'pin-hole'. The sectioned flange is shown in Figure 2. The location of the 'pin-hole' is marked with an arrow-head.

**Figure 2** Photographs showing where the Flange was sectioned at, for looking at the inside of the bore.

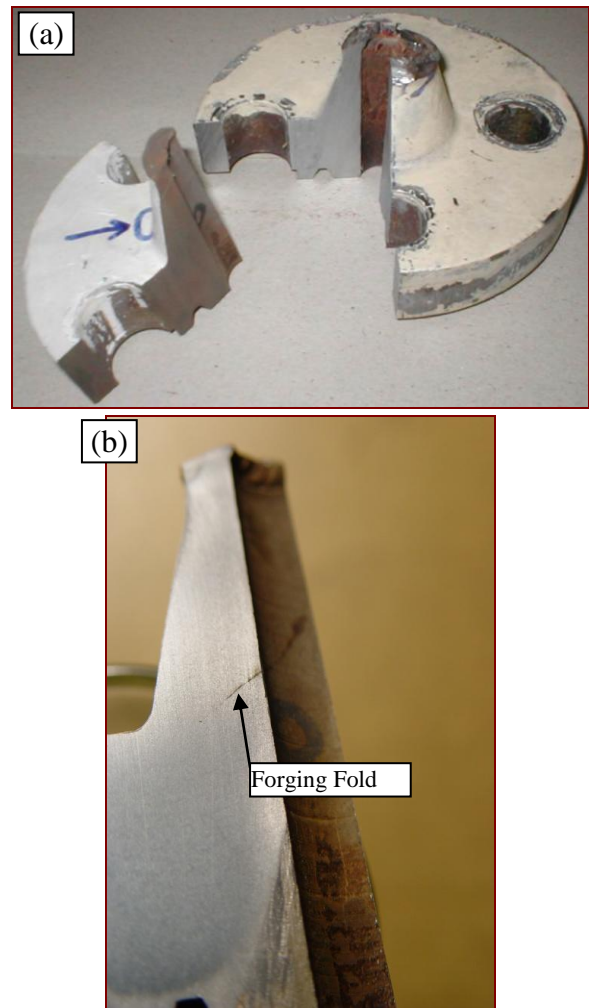
Although nothing very evident could be seen on the sectioned surfaces as such, when one face of the sectioned flange was metallographically polished and etched, a 'crack' which was later identified as a 'forging-fold' became visible. A photograph of this forging-fold is given in Figure 3. It may be noted that the fold extends up to the inner surface of the bore.

**Figure 3** (a) The photograph of sectioned flange. (b) The sectioned face which was polished and etched. A 'crack' that was essentially a 'forging-fold' can be clearly seen in Figure 3b.

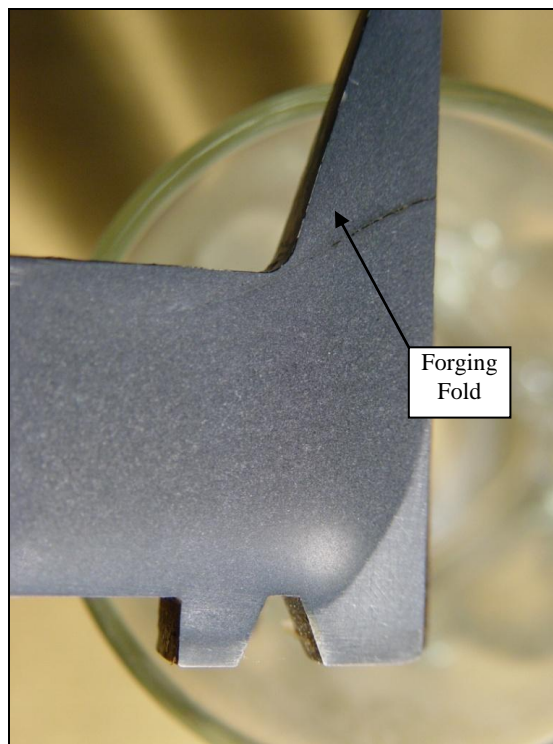
In order to understand the link of the forging-fold with the pin-hole at the outer surface of the flange, the sectioned portion shown in Figure 3(b) was further sliced very close to the 'pin-hole', a photograph of which is shown in Figure 4. It may be noted in Figure 4 that the forging-fold is oriented in a manner such that it serves as a 'connection' between the inside of the bore and the 'pin-hole' on the outer surface of the flange. Although it was possible to remove another thin slice from the section shown in Figure 4, in an attempt to illustrate the fold actually linking with the pin-hole, it was considered appropriate not to do this for two reasons:

**Figure 4** A section taken very close to the pin-hole, showing the orientation and the depth of the forging fold. It can be seen that the fold is serving as a 'connection' between the inside of the bore and the 'pin-hole' on the outer surface of the flange.

- (b) The sectioned portion of the flange was to be sent back to BHP Petroleum (and possibly for onward transmission to the manufacturing company in Australia). It was thought appropriate to leave the further slicing (if needed) to the forging company, so that they could carry out the remaining examination from their own point of interest, i.e. how the forging fold could have formed, so as to improve/modify the blocking/pre-forging step.

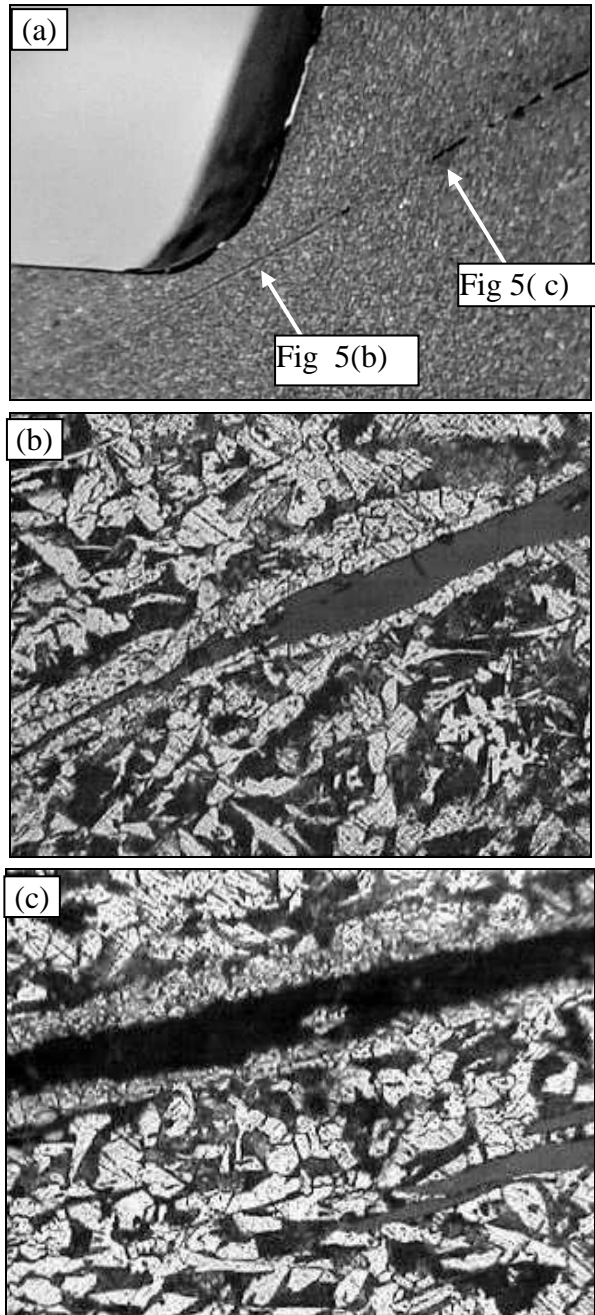
An analysis of the above observations should be conducted in conjunction with the information that the leakage through pin-hole was noticed six months after the installation of the flange. It is logical to believe that the condensate in the gas had caused a slow chemical attack on the oxide entrapped in the fold, and it took about six months for the condensate to eat away sufficient oxide so as to create a leakage path through the fold.

The compositional analysis of the gas given in Section 2 above shows no H<sub>2</sub>S in the gas, however, the CO<sub>2</sub> content was about 2.6 %. The H<sub>2</sub>S and CO<sub>2</sub> are both soluble in water (condensate), and result in the formation of sulphuric and carbonic acids, which are corrosive to iron as well as iron-oxide. In fact the iron-oxide dissolves into the sulphuric or carbonic acid more readily than iron [6-10].

The microstructures given in Figure 5 also show that the entrapped oxide scale is sandwiched between continuous layers of decarburized steel. This observation clearly shows that the oxide seen in Figure 5 is not an intrinsic inclusion, but is the oxide scale that had formed at the surface of hot metal, and had been entrapped inside the fold when (due to inappropriate handling of forging stock) a forging fold was developed during forging. It has to be remembered that when a stock is being heated in a furnace prior to being forged, the surface scale as well as a decarburized layer always forms on the surface as it is exposed to atmospheric oxygen. It is therefore clear that the oxide layer seen in Figure 5 had its

origin in the forging fold, and that the oxide had been gradually attacked by the acidic condensate in the gas eventually resulting in the leakage.

**Figure 5** (a) A macroscopic view of the fold, (b) micrograph showing that the oxide entrapped inside the fold, (c) another micrograph indicating that the oxide has been eaten away at some locations in the fold, thus providing a leakage path to the gas / condensate.
