Metallurgical Analysis of High Pressure Gas Pipelines Rupture

Abstract

On 6 July 2004, two parallel-running gas pipelines (18-inch and 24-inch diameters), in the main transmission network of SNGPL (a gas company in Pakistan) were ruptured. The ruptures occurred in the early hours of the morning about 8 miles downstream of the compressor station AC-4. The ruptures were indicated by the increased gas flow at the outlet of AC-4 [1], first at about 0648 hours and then again about 20 minutes later. The gas escaping from the ruptured lines had caught fire, and the flames had also 'affected' a third parallel-running pipeline of 30-inch diameter, lying next to the 24-inch line.

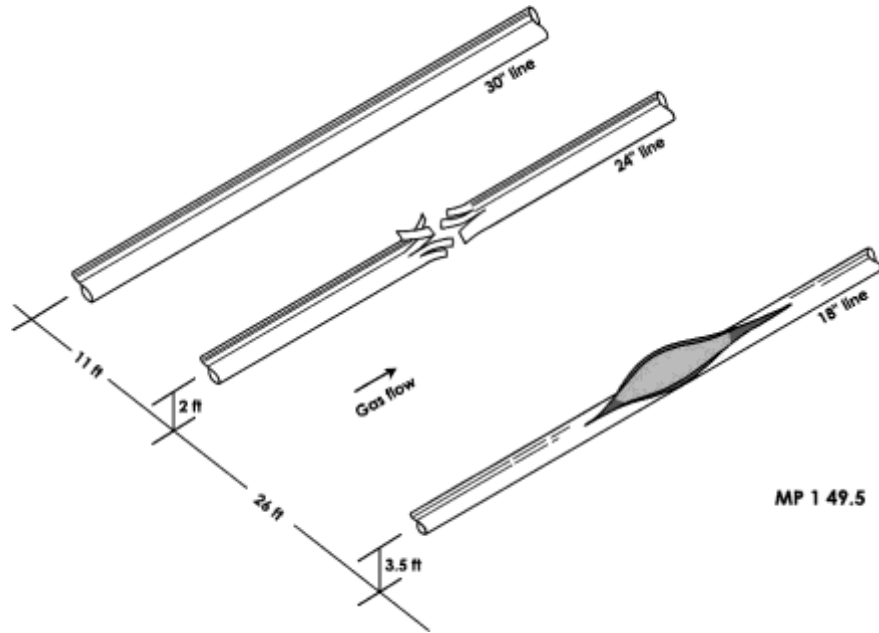
Figure 1 below is an illustration of the layout of the three pipelines, as well as the manner in

Figure 1: A schematic illustration of the layout of three pipelines, also indicating the manner in which the 18 and 24 inch lines had ruptured. The rupture-location was about 8 miles downstream of the compressor station AC-4.

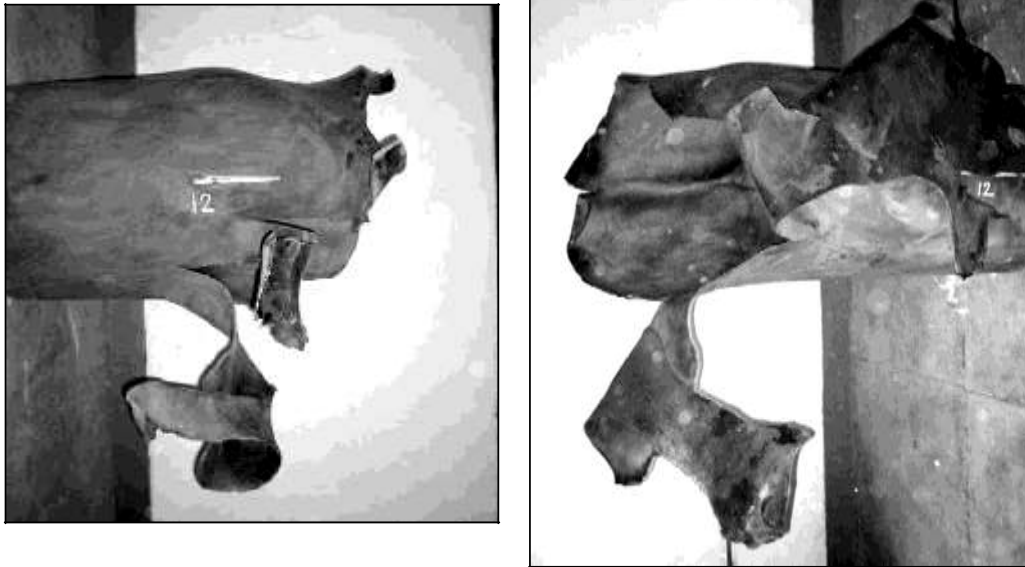
Figure 2: Photographs of the two broken ends of the 24-inch pipe, taken from the 12 o'clock angle.

The geometrical configuration of the 24-inch diameter ruptured line is illustrated in Figure 1, while the photographs of the broken ends of this pipe are given in Figure 2. As indicated by Figures 1 and 2, the 24-inch pipe had broken apart by the force of the blast. The inward 'dents' at the 7 o'clock position* on both the broken ends of the pipe indicated that the explosive device had been placed beneath the pipe. Figure 3 shows the 7 o'clock position dent on one of the broken ends. (*The clock position represents the position of the pipe section looking along the gas-flow.)

folded) portions of the two pipe-ends (shown in Figure 2) were straightened and matched with each other, it would be found that the pipe had lost no material from its walls. Further, it would be revealed that the underside of the pipe had cracked both longitudinally as well as circumferentially by the blast, and that the cracked portions there-from had gone on to hit the upper wall from inside producing the dent seen in Figure 4.

The regions around the fracture show severe bending (or denting) of the pipe-wall, as may be seen in Figures 2, 3, and 4. The geometrical configuration of the ruptured pipe provides considerable information about the forces/stresses involved in the fracture. A careful analysis of the broken edges of the rupture opening clearly reflects that such a damage to the pipe could not be the result of excessive gas pressure, or any shortcoming or fault in the pipe material. On the contrary, a logical interpretation of the heavily bent broken edges is that the pipe was attacked by some explosive device planted on the pipe.

On the basis of above observations, it has been concluded that the rupture of the 24-inch line was caused by an explosive device placed beneath the pipe at about 7 o'clock position.

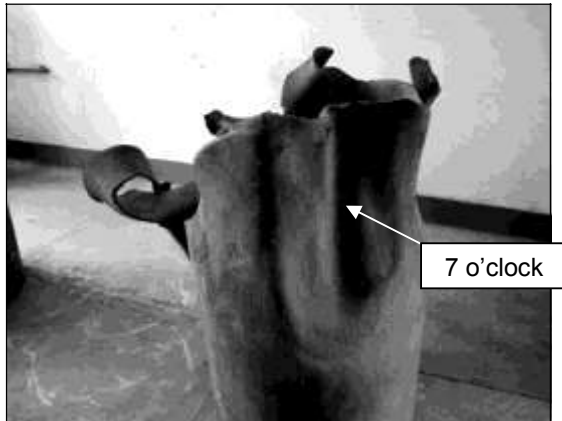
Figure 3: The large 'inward dent' at 7 o'clock position on the 24-inch ruptured pipe.

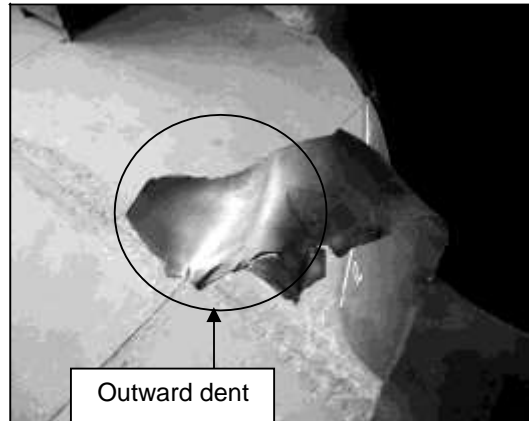
An interesting feature of the rupture may be noticed in the photograph shown in Figure 4. This portion of the 24-inch pipe approximately corresponds to 1 o'clock position, i.e. almost exactly opposite to the 7 o'clock. An outward dent observed at this location suggests that either a portion of the explosive device or a part of the broken pipe from the lower side of the pipe had gone on to hit the opposite (upper) wall of the pipe from inside. It may be mentioned that no broken part of the pipe or any foreign object was recovered either from the site or from inside the pipe.

Figure 4: The outward dent at about 1 o'clock position on the 24-inch pipe

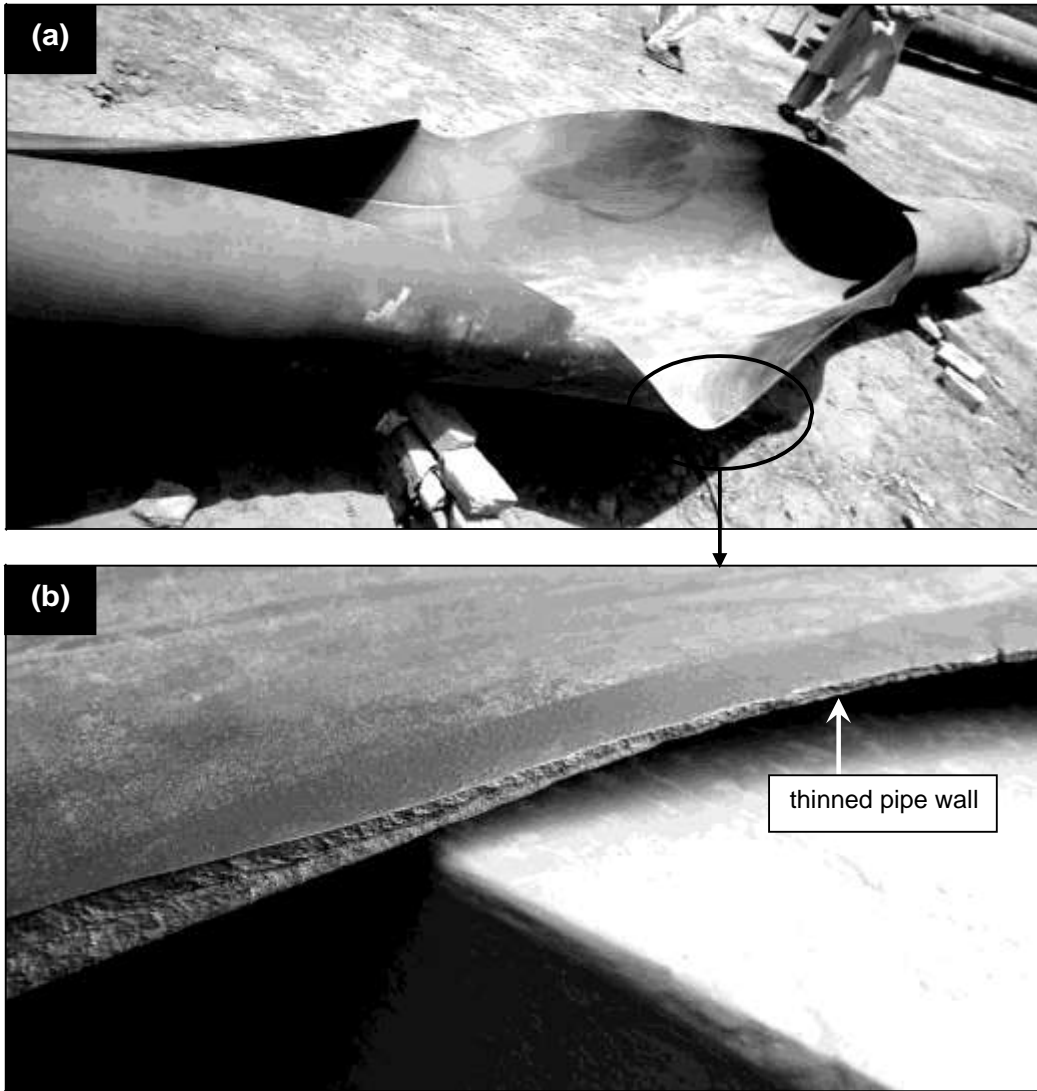
A schematic illustration of the rupture of 18-inch line has been given above in Figure 1. Photographs of the ruptured pipe are given in Figure 5. As shown by the Figures 1 and 5, the pipe had fractured longitudinally, with the crack located at about 10.30 o'clock position.

The most significant feature of the fracture surface, as shown in Figure 5(b), was the thinning of the fracture-edge over a length of about 24 inches. The circumferential perimeter of the pipe at the location of thinned wall was measured to be 147 cm, while that measured at the un-cracked region was 144 cm. These observations clearly suggest that the pipe had yielded plastically before fracturing under the influence of the inside gas pressure.

Figure 5: Photograph of the 18-inch ruptured pipe is shown in (a), while a magnified view of the encircled portion is shown in Figure 5 (b) The thinned portion of the pipe-wall on the 18-inch pipe may be noted in Figure 5b.

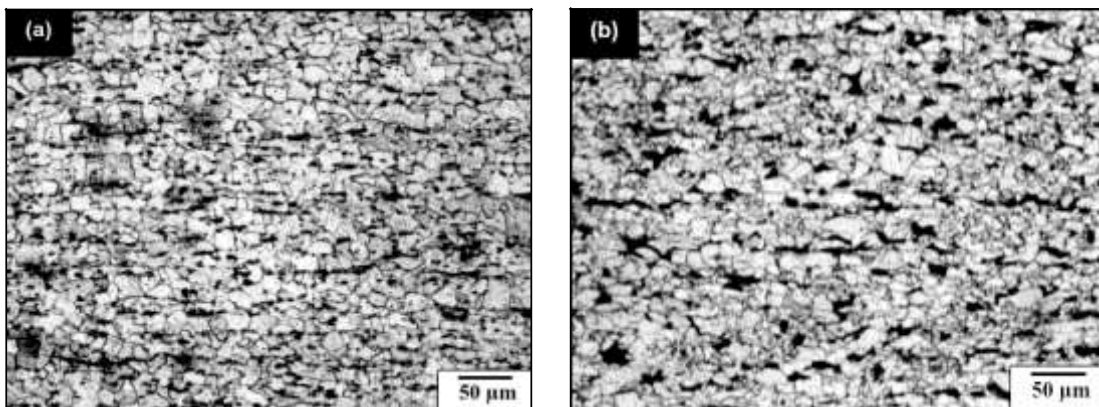
It was imperative to suspect that the localized plastic yielding of the 18-inch pipe must have been connected to the flame from the 24-inch pipe. In order to verify this, samples taken from selected locations on the affected regions of the 18-inch pipe were prepared for metallographic examination. One of the microstructures, given in Figure 6a, was taken from a location, where a sizeable thinning of the pipe-wall (like that seen in Figure 5 b) had taken place.

For comparison, a micrograph of a sample taken from 18-inch pipe from a location that was well remote the affected region of the pipe is given in Figure 6b. This microstructure essentially consists of ferrite and a very small proportion of pearlite. The grain size of the ferrite phase was measured to be around ASTM Size 9-10.

A comparison of the microstructure of Figure 6a with that of Figure 6b shows that the distribution of the pearlite phase has been noticeably modified. The pearlitic areas in the original microstructure of Figure 6b can no more be observed in Figure 6a, which clearly indicates that the steel must have been heated upto the austenitic region of iron-carbon phase-diagram. Heating to austenite would once dissolve the pearlite phase which would then precipitate out with a distribution depending upon the cooling rate [3]. It reflects that the temperature at some locations must have exceeded 800-850°C.

The high temperature tensile data of low-carbon steels shows that at 750-800°C the yield strength drops to about one third of its room-temperature value [4]. Accordingly, taking into account the wall-thickness, the diameter, and the yield-strength of the 18-inch pipe (see Table 1), simple calculations would show that a gas pressure of 700-750 psi could have caused the yielding of the pipe-wall. This estimate matches quite well with the gas pressure of about 700 psi, which was reportedly observed at the outlet of AC-4 [1] about 20 minutes after the first rupture was indicated by the increased gas flow. It must be kept in mind that the above calculations are only a very rough estimate aimed at establishing a correlation between the gas-pressure and the temperature of pipe-wall at the time of failure. Nevertheless, these calculations do convincingly indicate that the temperature of the 18-inch pipe over a small region, under the influence of the heat from 24-inch pipe

Figure 6: Microstructures taken from the thinned (heated) region of the pipe (a), and in (b) from an un-affected portion of the 18-inch pipe showing that the microstructure has been measurably changed.

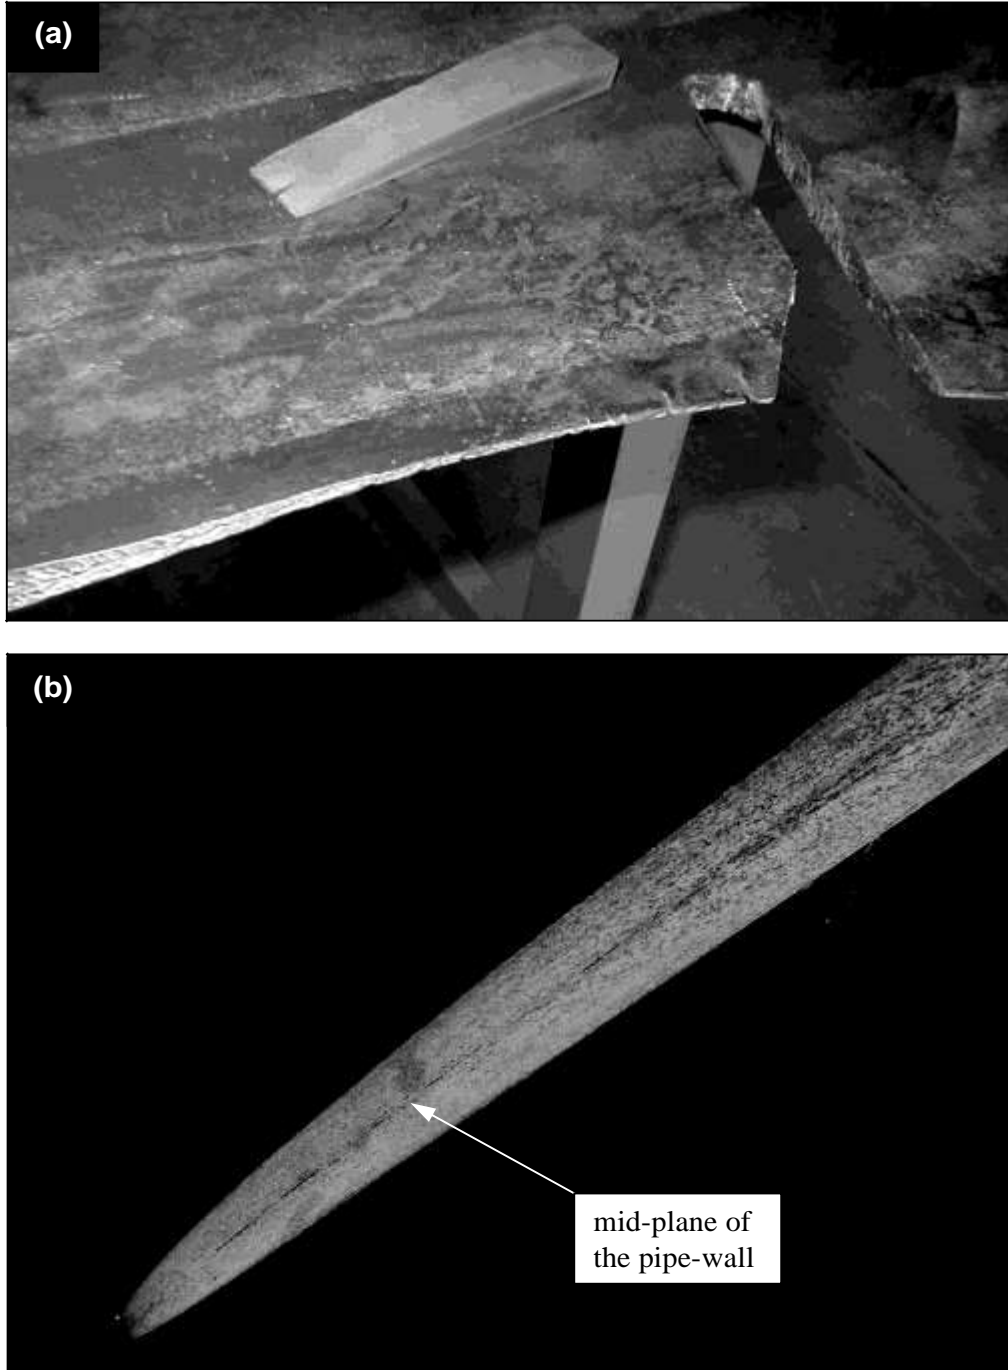
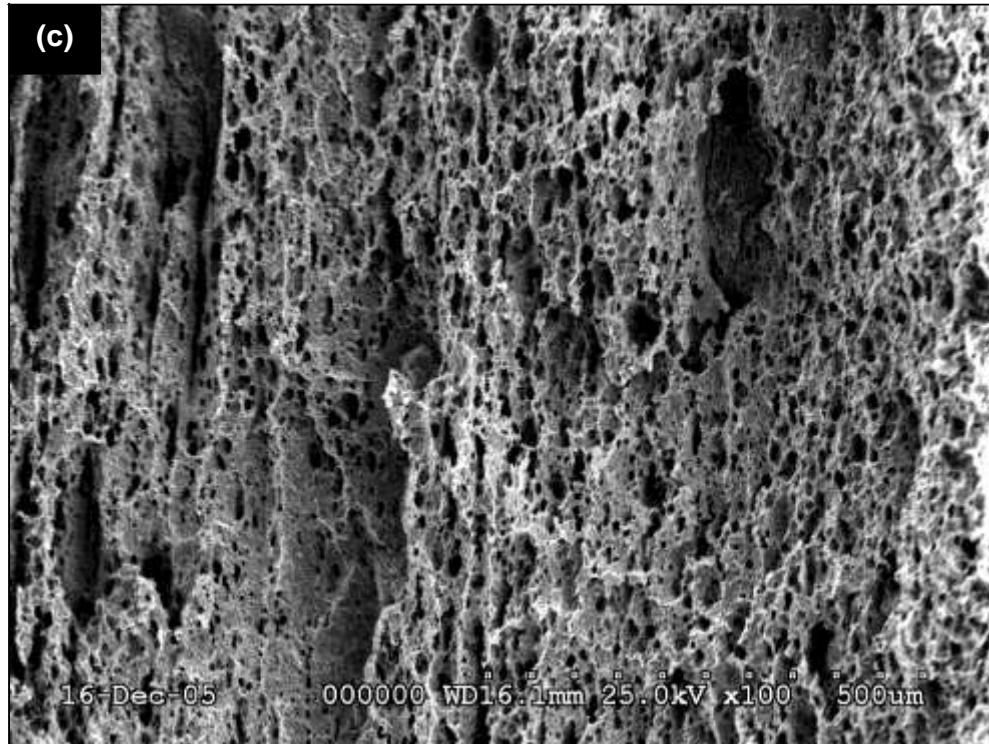
A sample taken from the pipe-wall for macro-examination, shown in Figure 7a, illustrated that the pipe-wall had fractured in typical tensile mode. A magnified view of the same specimen

(Figure 7b) clearly shows that the thinning of the wall was entirely due to the tensile straining of the heated portion of the pipe-wall. The thinned edge of the specimen was also observed using SEM (see Figure 7c). This fractograph is typical of ductile fracture [5] showing that pipe had fractured in a tensile mode.

Figure 7: (a) A sample taken from the pipe for macro-etching showing the profile of the thinned wall along the fracture line, and in (b) the mid-plane of the pipe wall revealed by the macro-etching (c) SEM fractograph showing that the sample had fractured in tensile mode.

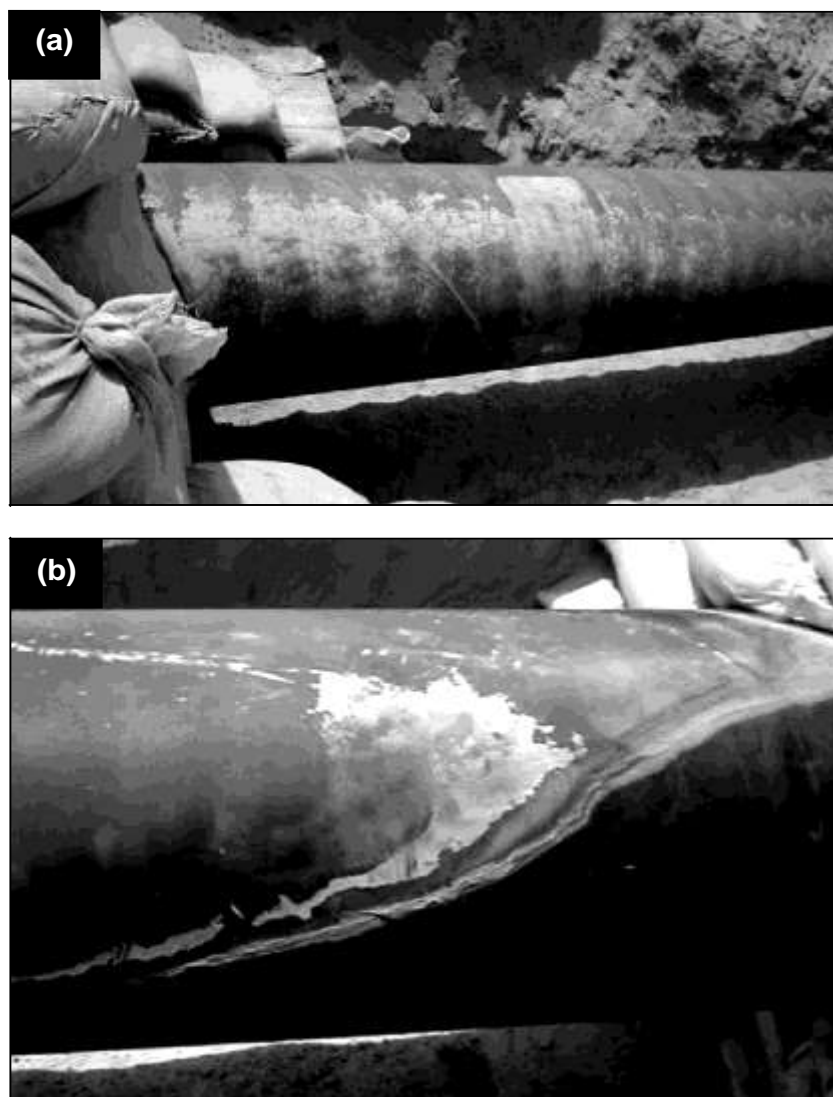
The 30-inch pipe was affected by the fire to the extent that its coating, on the side facing the 24-inch pipe, had been burnt. Photographs taken from the affected region are shown in Figure 8. It was noted that although the 'black' polyethylene (PE) upper layer had been burnt off, the presence of inner 'off-white' resin layer suggested that the temperature of the pipe surface had possibly not exceeded about 200°C, which in turn would reflect that little damage must have been done to the pipe steel.

Additionally, the visual examination of the pipe did not show any sign of distortion, deformation, or de-shaping what-so-ever. It was on this basis that the SNGPL engineers had decided not to replace the affected portion of the 30-inch pipe. However, the pipe was left un-coated, so that any metallurgical examination could be carried out.

Figure 8: Photographs of the affected portions of the 30-inch line. The ‘off-white’ layer of epoxy-resin beneath the black polyethylene layer may be noticed.

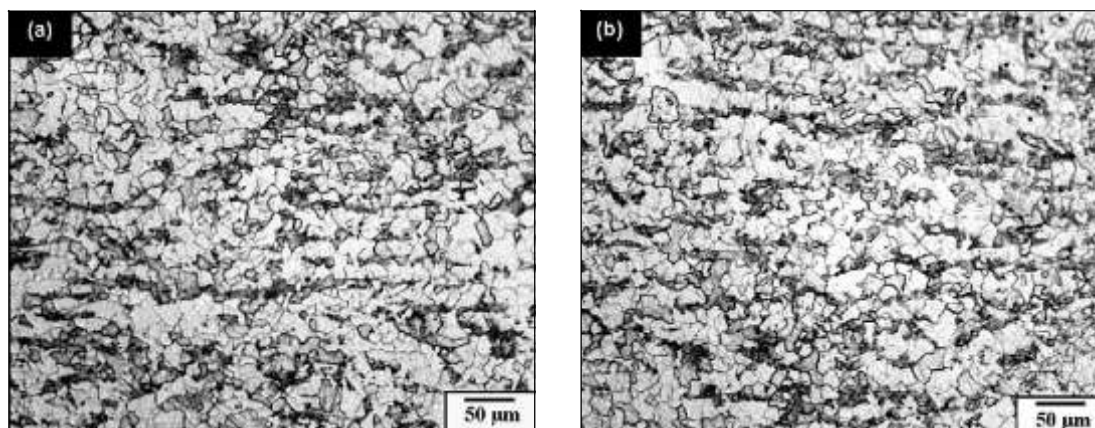
both from the affected region as well as from the un-affected region, and compared. The replicated microstructures taken by the Struers Rubber Replica method [6] are shown in Figure 9. It may be pointed out that taking the replica from the pipe surface proved a very difficult exercise for two reasons; (a) the continuous flow of sand and dust onto the pipe-surface during the metallographic preparation, and (b) the temperature of the pipe surface.

A comparison of the microstructures of the affected and the un-affected regions (Figures 9 a & b respectively), shows that no measurable change in the microstructure of the pipe material has been caused by its heating. Figures 9a & b successfully indicate that there is no difference in the two microstructures on account of both the grain-size as well as the pearlite distribution. This observation, therefore, re-affirmed the decision that the 30-inch pipe was safe for use, and did not need to be replaced.

Figure 9: Metallographic replicas obtained from (a) the ‘affected’ portion of the 30-inch line, and, (b) from the ‘un-affected’ portion, showing that there was little difference in the two microstructures.

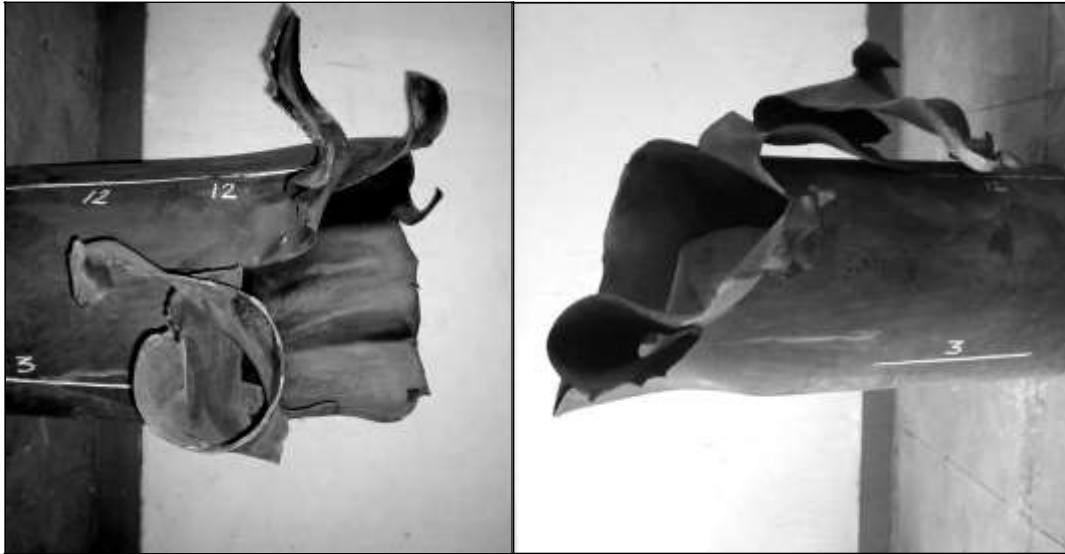
Figure 10: Photographs of the two broken ends of the 24-inch pipe, placed against each other in the same orientation as they were soon after the rupture. The 12 o'clock and the 3 o'clock positions on the two pieces are also indicated. It may be appreciated that in with this positioning of the rupture opening, the gas escaping from the 24-inch pipe would have been preferentially directed toward the 18-inch pipe.

The answer to this question can be found in Figure 10, which shows the two broken ends of the 24-inch pipe placed against each other in the same manner as they were following the rupture. The 12 o'clock and the 3 o'clock positions on the two pieces are also indicated. It must be realized that the 18-inch pipe was located towards the 2.30 o'clock direction, and the 30-inch pipe was located opposite to that. It can be easily seen that the profile of the rupture-opening, as shown in Figure 10, was such that the gas jetting out of the rupture-hole would have been preferentially directed towards 2-3 o'clock position, i.e., towards the 18-inch pipe.
