***Darbār* Hall of the Governor House, Peshāwar: Preliminary Report on its Recent Restoration and Conservation**

MUHAMMAD WAQAR

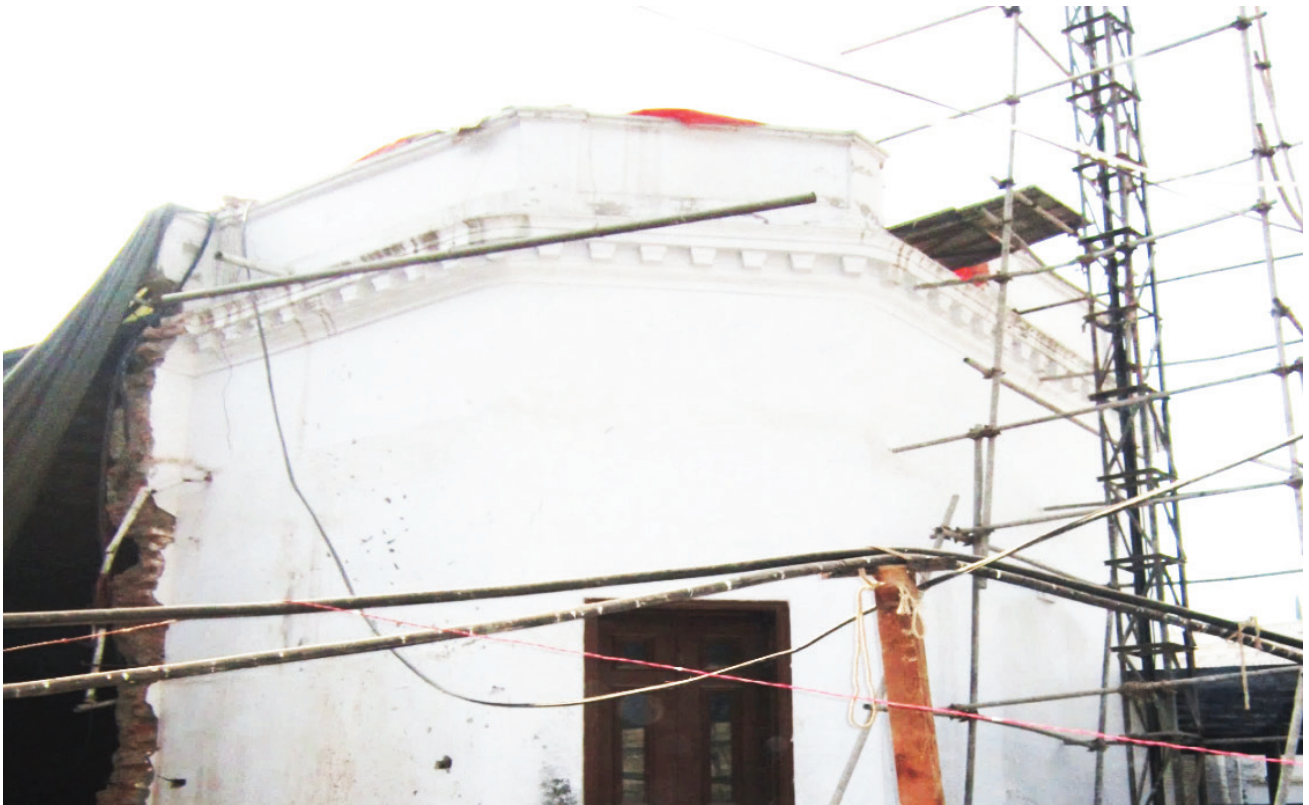
The cracked portion was completely removed from rest of the structure of *Darbār* Hall (Pl. 5). This portion was connected with *Jirga* Hall from backside through a door. The roof of the hall is made of steel girders-frame, overlapped by rectangular burnt-bricks (*chawka*). Furthermore, wooden-ceiling provided to the roof (Pl. 6). The thickness of the walls is about 85 cm, provided doors and windows at regular-intervals, having symmetrical height. It is also provided wooden-floor, which is 118 cm high from original floor-level like Peshāwar Museum main hall (Pl. 7).

Plate 5: Demolished Portion

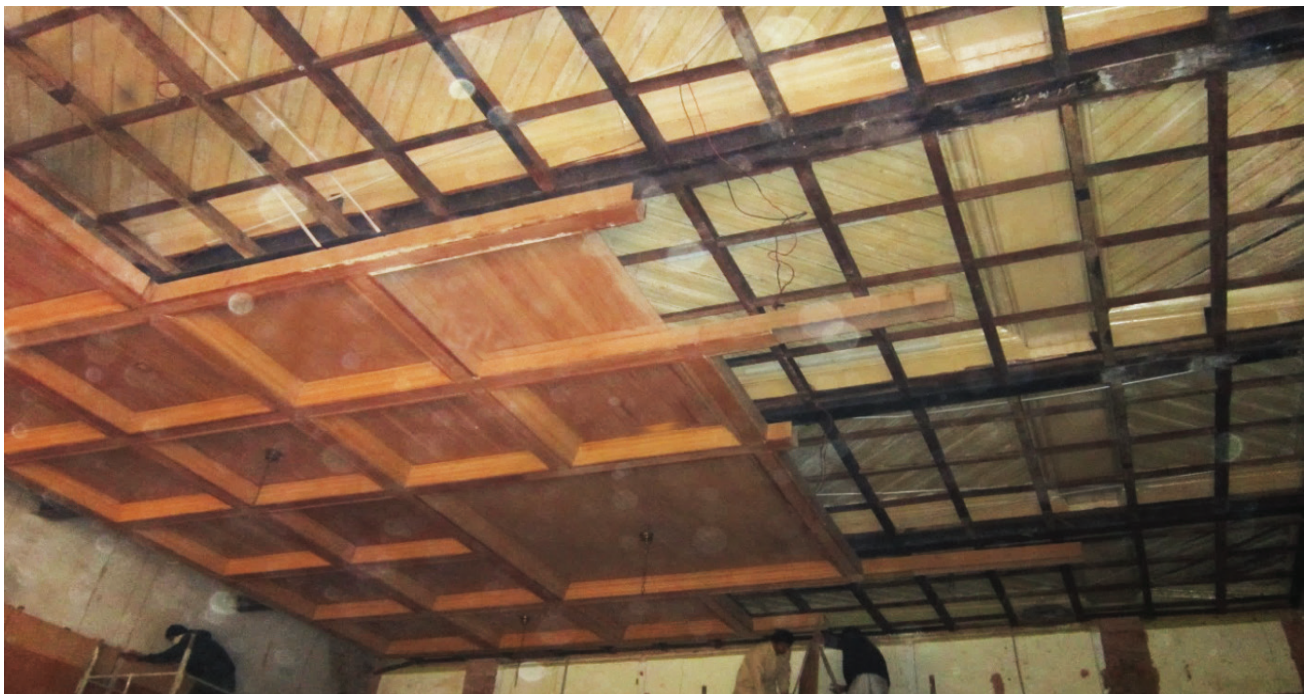
Plate 6: Roof-ceiling from inner side

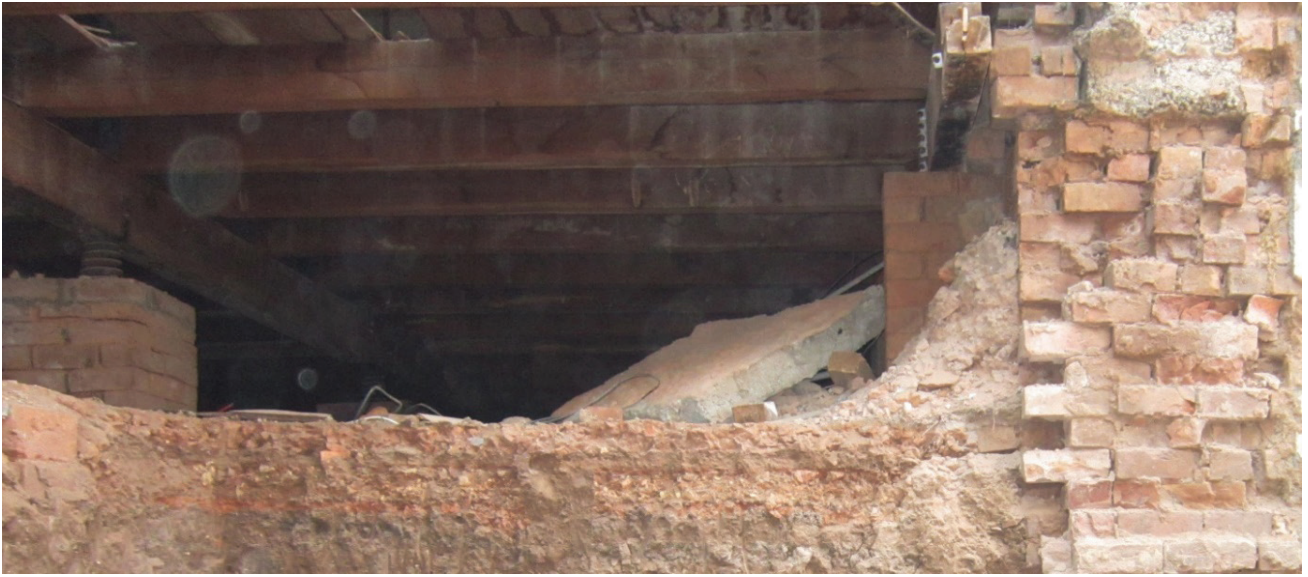
Plate 7: Wooden floor-level

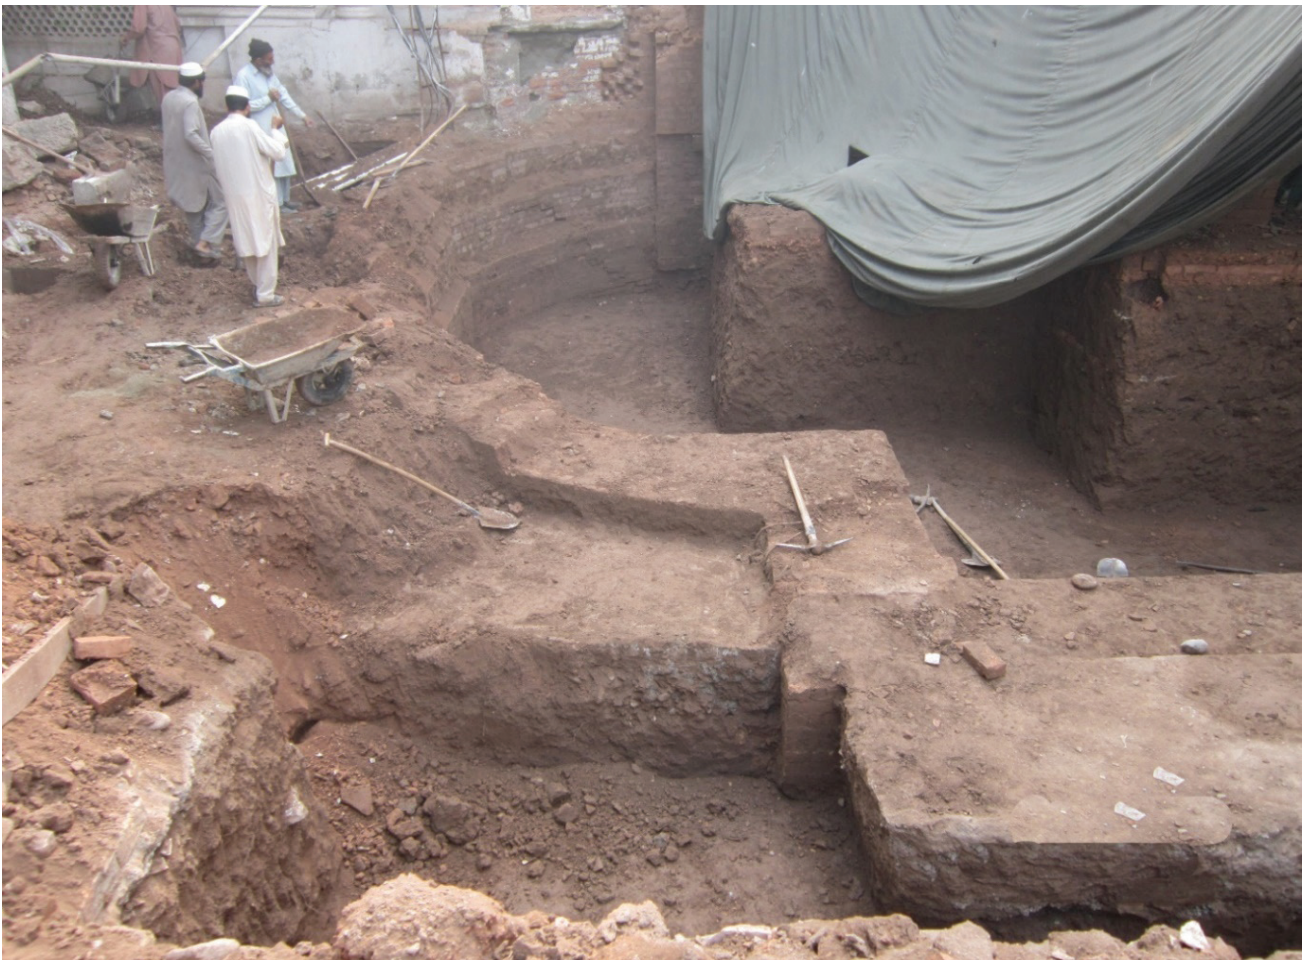
For removal of a cracked portion of *Darbār* Hall, the concerned engineers selected an area of about 1300 sq. ft. towards the north-eastern side for digging foundations of the hall (Pl. 8). The selected area was dug out up to the depth of 210 to 220 cm. The depth shows a complete profile in the section-wall. The original floor-level shows hard surface made of burnt-bricks, small & large pieces of broken bricks etc. Below the original floor-level traces of layers can be observed at the depth of 55 to 85 cm, with a thickness of 20 to 25 cm, varied at different portion in the section-wall. The said layer is composed of stucco/lime, local reddish soil (*khakka*) and pebbles. This layer continuously runs through the section (Pls. 9 & 10). One of the most important findings reported from this section was a concrete-pipe, exposed at the depth of 85 cm, it measures 14 cm in diameter (Pl. 11). The exact location of the pipe is unknown, from where

Plate 8: Foundations are clearly visible after removal of cracked portion

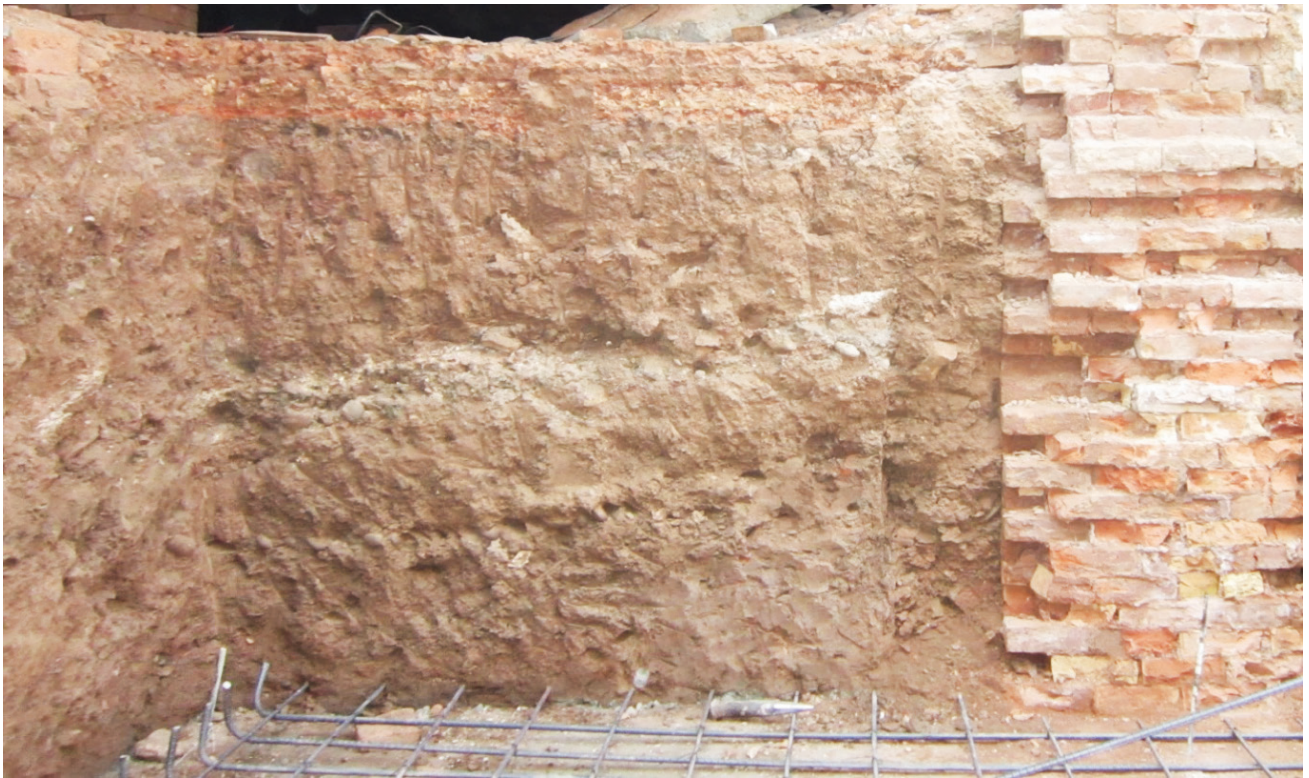
Plate 9: Western section with foundation of a wall structure

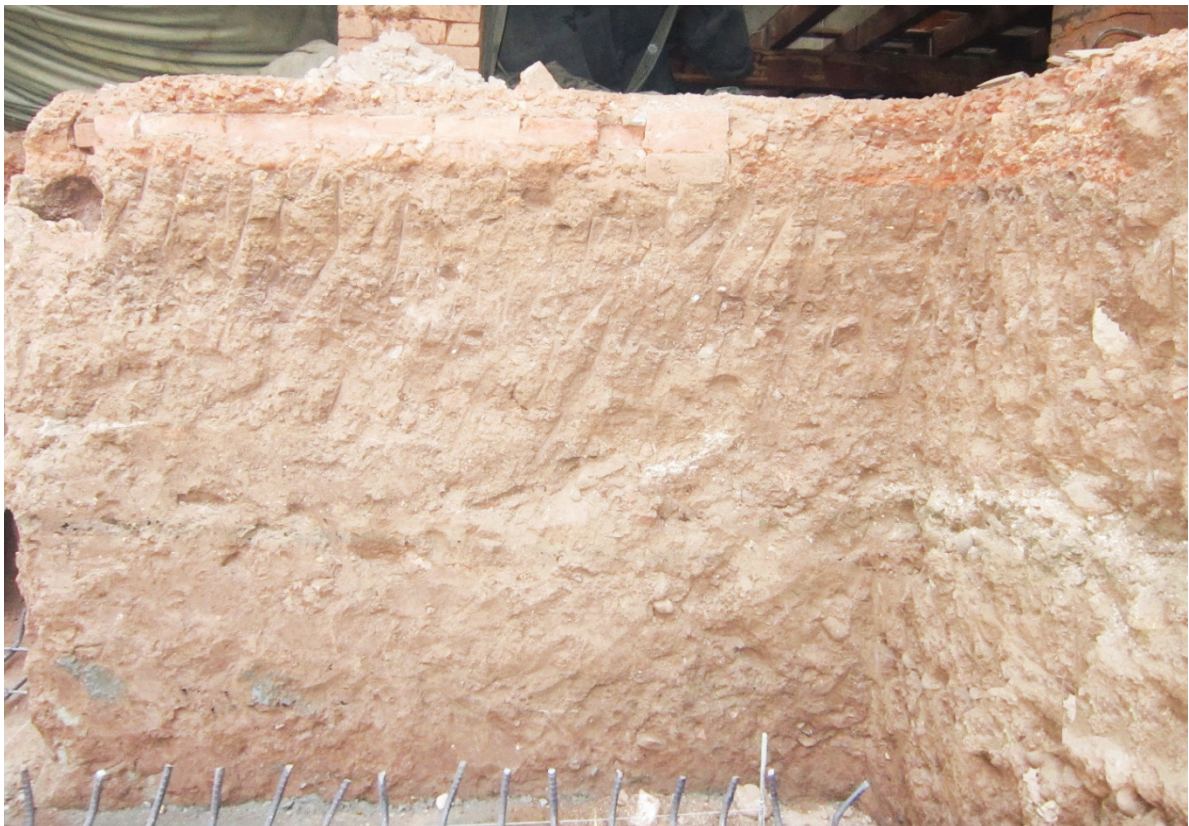
Plate 10: Southern section

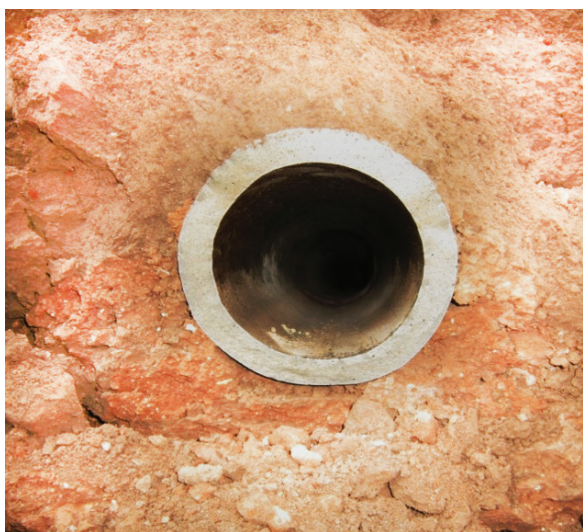
Plate 11: Concrete-Pipe, western section

it starts and where it ends. Another similar pipe was exposed in the northern section-wall (Pl. 12), at the of depth 115 cm. During the digging and removal of debris both the pipes were damaged. Most probably, these pipes were used for drainage during the Colonial period.

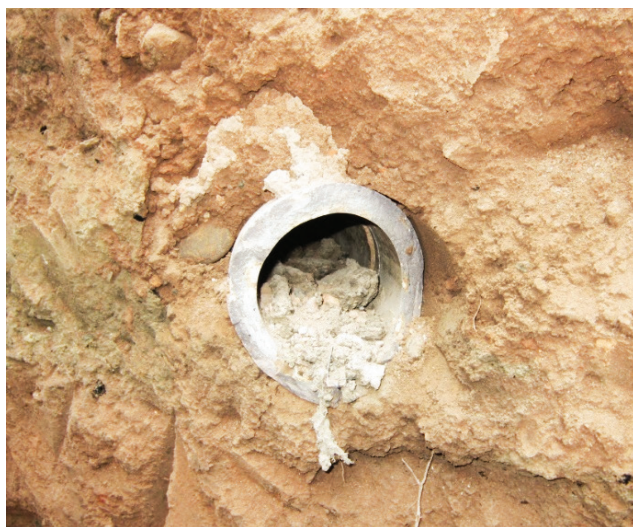
Plate 12: Concrete-Pipe, northern section

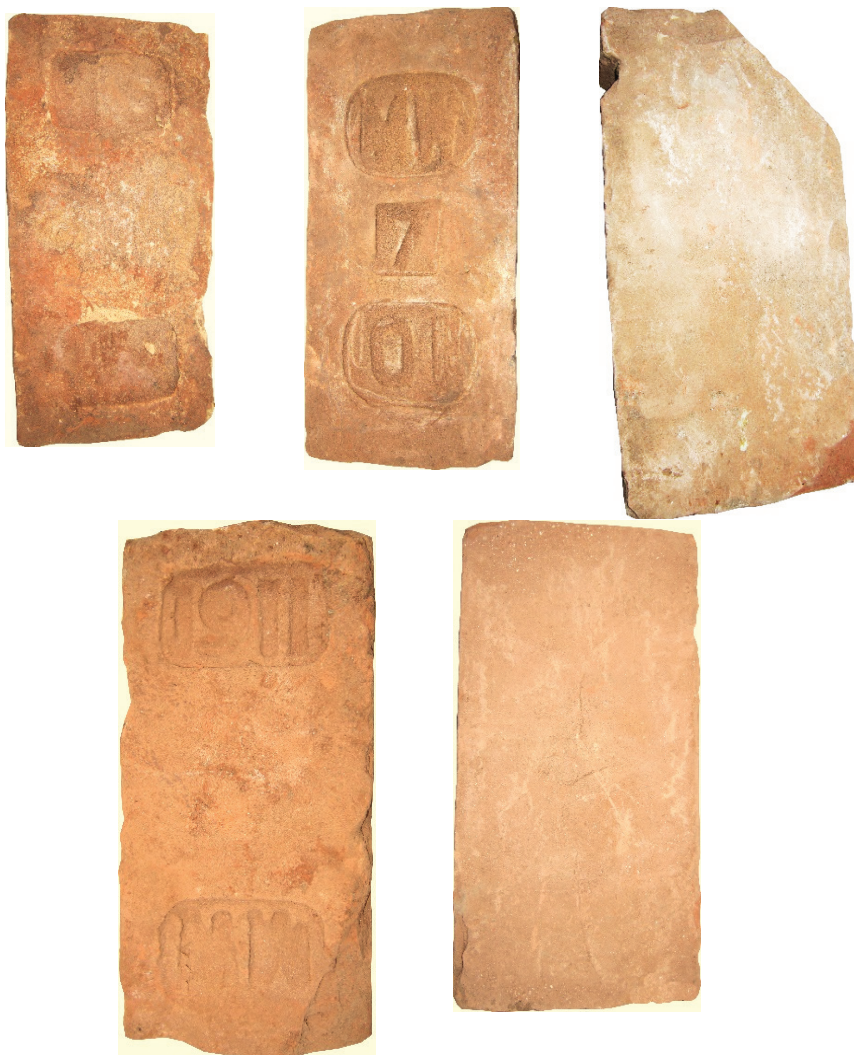
During the restoration and conservation work in the damaged part of the Darbār hall, the following materials were recovered i.e. including burnt-bricks of various shapes and sizes (30 x 15 x 7, 30 x 15 x 5 cm). Mostly, these bricks were rectangular having sufficient width (Pl. 13). The bricks, which were used here, are the typical colonial period bricks thicker than the Waziri bricks, used by Mughals and Durranis. The binding material reported in the form of stucco/lime, mixed with local reddish-soil (*Khakka*), with a small amount of crush, which is later blended with the modern material providing better safety.

Plate 13: Various types of burnt-bricks recovered during restoration work at *Darbār* hall
