Chumaduthangi (Load Relieving Stones) of Thalappilly Taluk in Thrissur District, Kerala, India

ARYA P. N., ANANTHU V. DEV, RAJESH S. V. AND ABHAYAN G. S

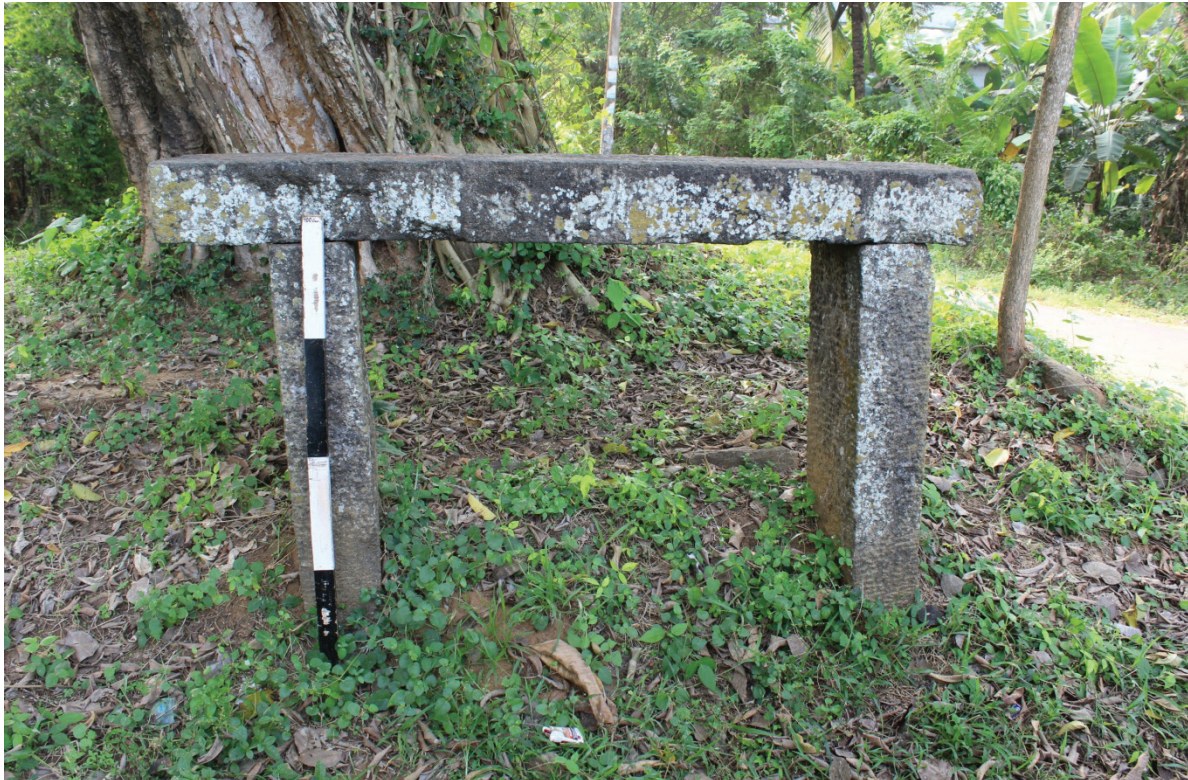
Figure 3. Two pillar Chumaduthangi, Venganellur

In Thalappilly *chumaduthangi* is mostly made out of charnockite rock but laterite stones can also be seen. Architecturally it resembles a stone bench or table i.e.; one or two dressed rectangular horizontal slabs placed on two or three dressed rectangular vertical stone pillars (Figs. 3 and 4). The tallest among them has a height of 2m and the longest among them has a length of 5.5m. During the exploration only one *Chumaduthangi* made of laterite was found in broken condition (Fig. 5). Most of the *Chumaduthangi* contain inscriptions, simple artworks and symbols on them. Most common symbol is that of a flower (Figs. 6 and 7). It has been found at the edges or at the centre of the horizontal slab. Fingers pointing towards left and right sides of the inscription are present

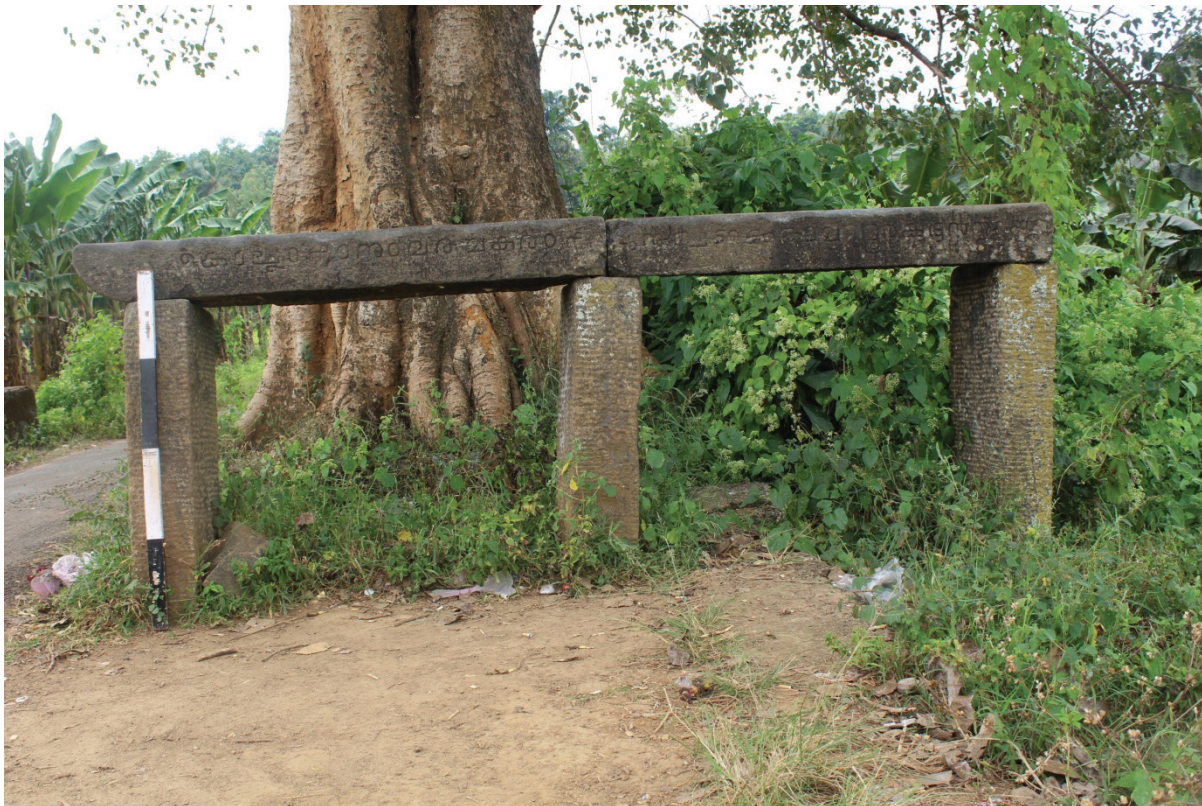
Figure 4. Three pillar Chumaduthangi, Pilakkode

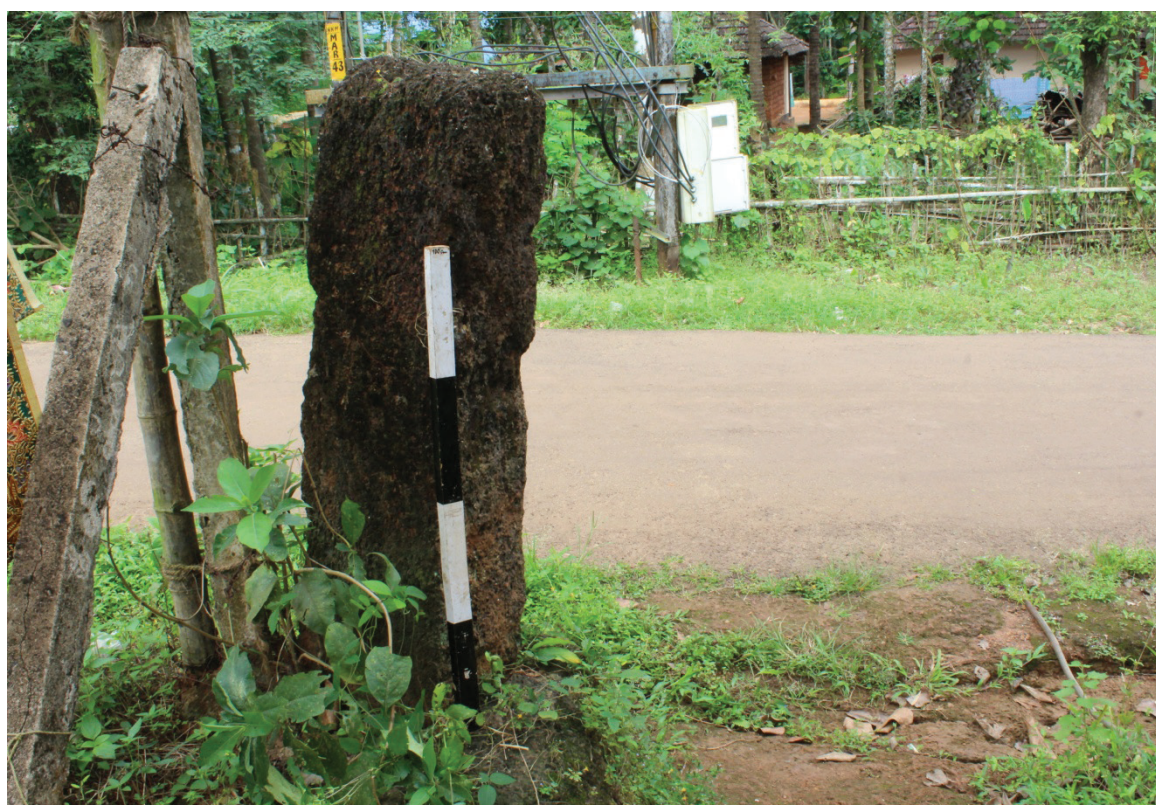
Figure 5. Broken laterite Chumaduthangi, Eyyal Parappuram

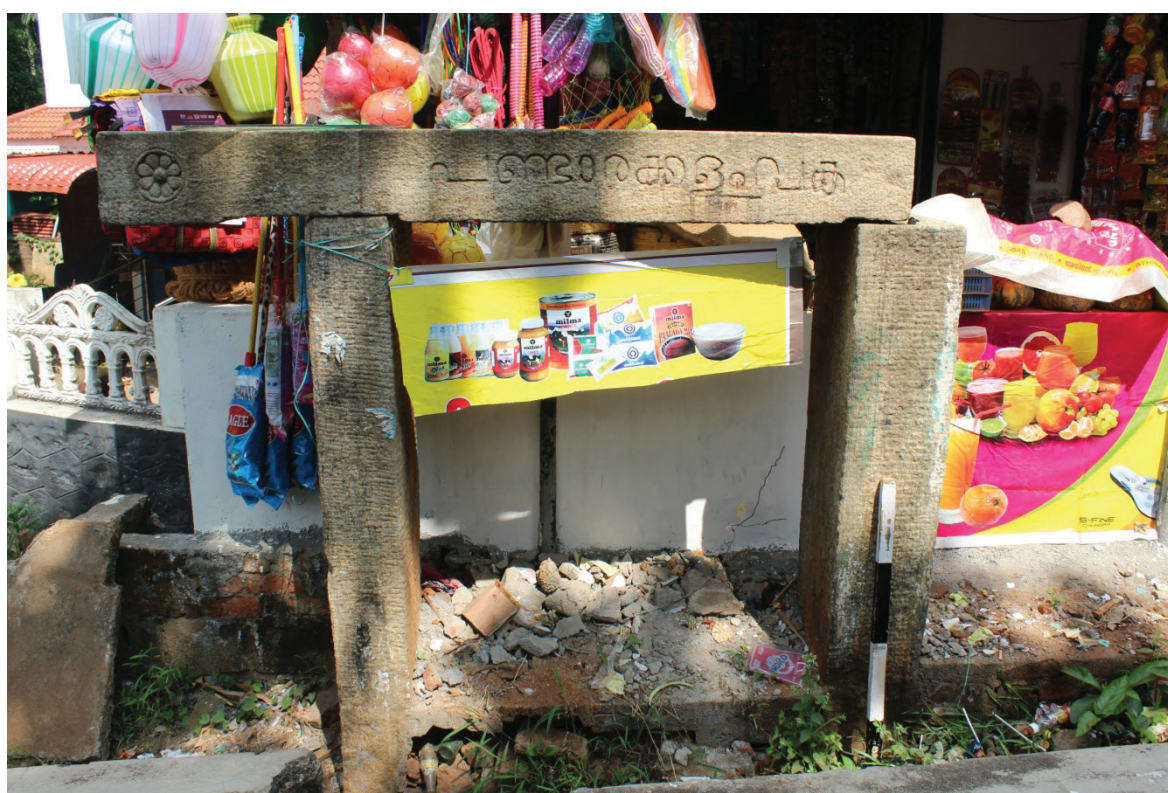
Figure 6. Chumaduthangi having flower symbol and Inscription, Kootupaata

It was seen that 34 *Chumaduthangi* have small inscriptions and many of these are legible. The inscriptions are engraved on horizontal stone blocks and the script used is the old Malayalam (Fig. 6). These valuable sources provide information about the year, month, name of the donor, name of his/her house and lineage. It was observed that the donors are mostly men. In some instances, name of females can be seen, which indicate that particular structure was erected by or on behalf of a lady whose name is inscribed on it. According to popular belief in early times, such donations were made by woman for avoiding risks during pregnancy (Jenee Peter: Personal communication). From the donor's names mentioned in the inscriptions it is noted that in Thalappilly, the *Chumaduthangi* were erected by the Hindu community only. In other places of Thrissur district constructions by the Christians and Muslims can also be seen.

Though many of the *Chumaduthangi* in the study area are in good state of preservation; nowadays majority of the monuments are mainly misused by the political parties and locals to tie banners (Fig. 6) and to paint them for advertisement purposes (Fig. 9). Some people have used the broken stone slabs of *Chumaduthangi* for construction purposes as well. Some of the *Chumaduthangi* are in inaccessible condition due to vegetation growth and soil deposition. In many places *Chumaduthangi* are absent but the place name such as Poovathani (Poovathani derived its name from *Athani* or *Chumaduthangi* which had engravings of flower symbols on it) suggests the presence of them.

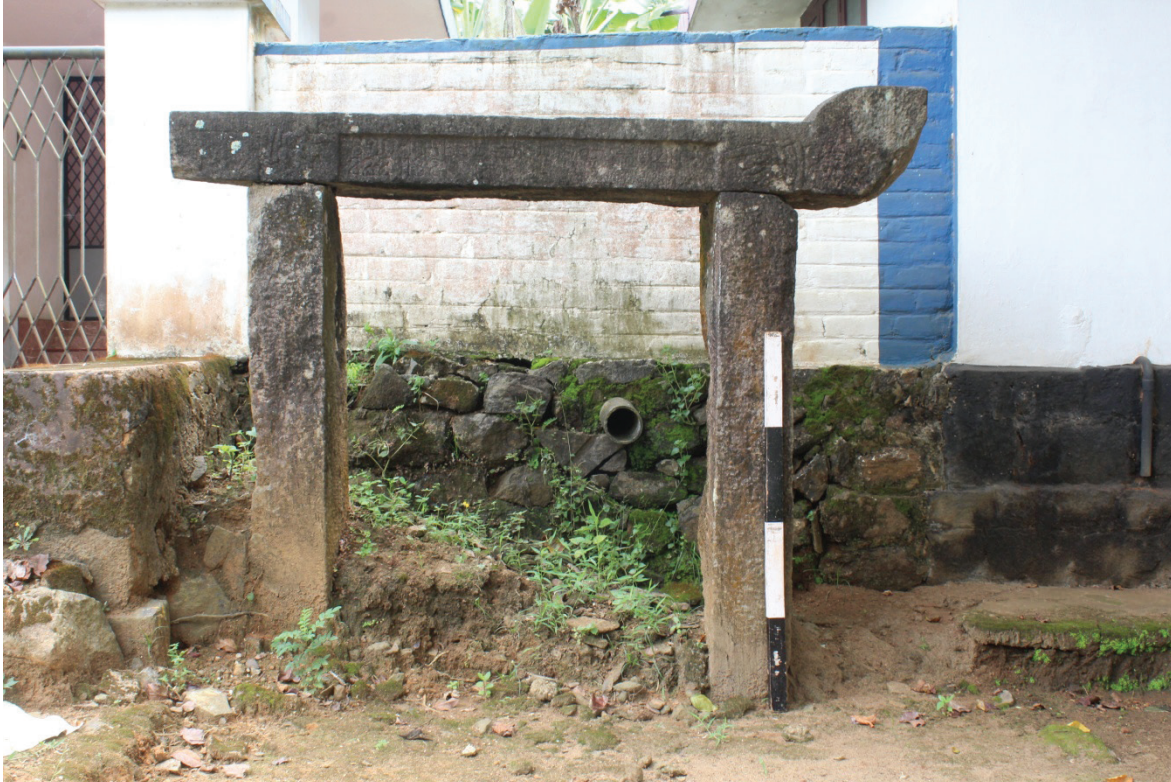
Figure 8. Chumaduthangi having Palm symbol and semi curved portion, Thichur

in the structure at Thichur (Fig. 8). In some of the *Chumaduthangi* one side of the horizontal slab has

a semi curved portion (Fig. 8) and the purpose of the same is apparently for decoration. Rarely present small conical step like projections on the vertical pillars seem to be meant for climbing on top of the horizontal block (Fig. 9).

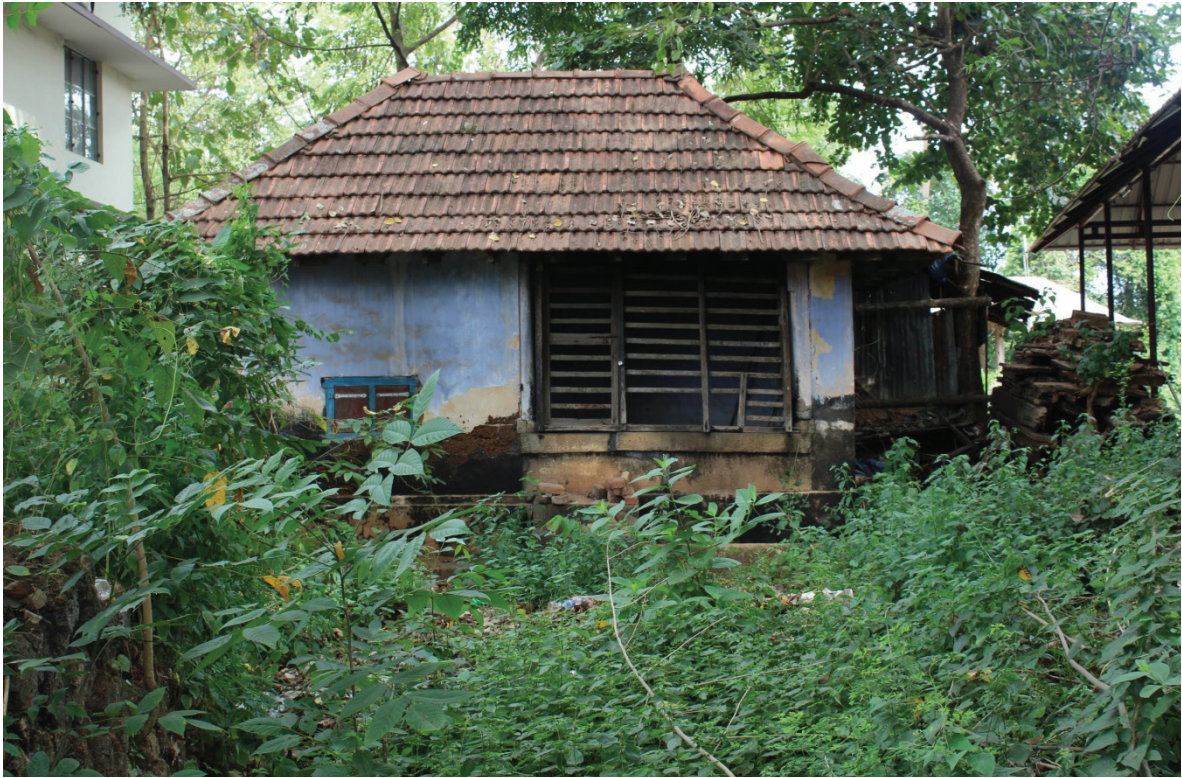
Figure 11. *Vazhiyambalam* at Chelakkara

In Thalappilly taluk, majority of the *Chumaduthangi* are found alone in most of the areas, while two are found in associated with *Vazhiyambalam*, locally known as *Thanneer panthal*. One is located at Chelakkara and the other at Pazhayannur. The *Vazhiyambalam* is a structure made of bricks and laterite blocks, to be used as a resting place for the people who travel long distances and carry commodities. It is a single roomed structure with two pillared veranda and a gabled roof. These were constructed and maintained by the upper class families or royal families of the respective periods. The oral tradition says that the travellers kept their luggage on *Chumaduthangi* and took rest in the *Vazhiyambalam*, where they could get drinking water and refreshments like butter milk. In the study area, the *Vazhiyambalam* look like small residential structures and they appear to be renovated and hence appear much later in date. The *Vazhiyambalam* at Chelakkara is partially

collapsed (Fig. 11). The other one located at Pazhayannur (Fig. 12) is presently functional during the festival at Pazhayannur Bagavathi temple. The *Chumaduthangi* are also found associated with *Karinkalthotty*, a basin like vessel made out of a single granite stone block. It was apparently used to provide water for domestic animals such as cattle. *Karinkalthotty* was reported from Vadakkethara and Pazhayannur.

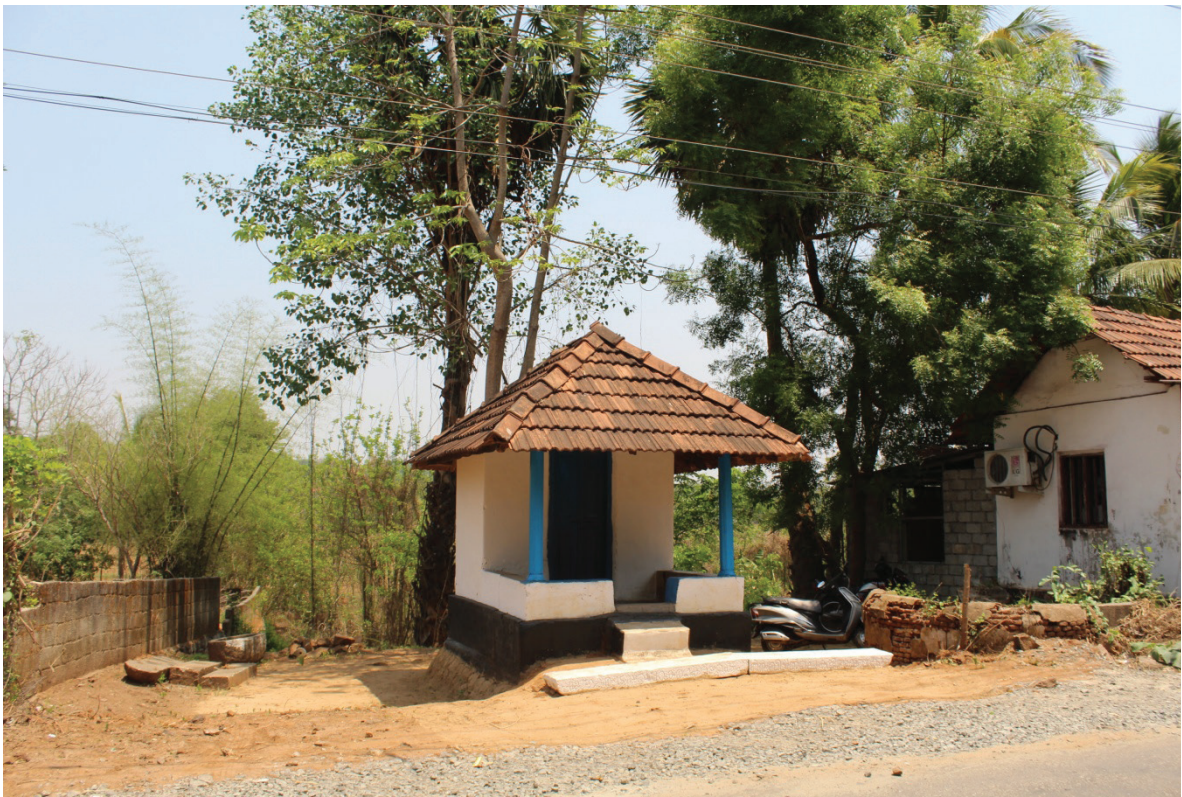
Figure 12. *Vazhiyambalam* at Pazhayannur

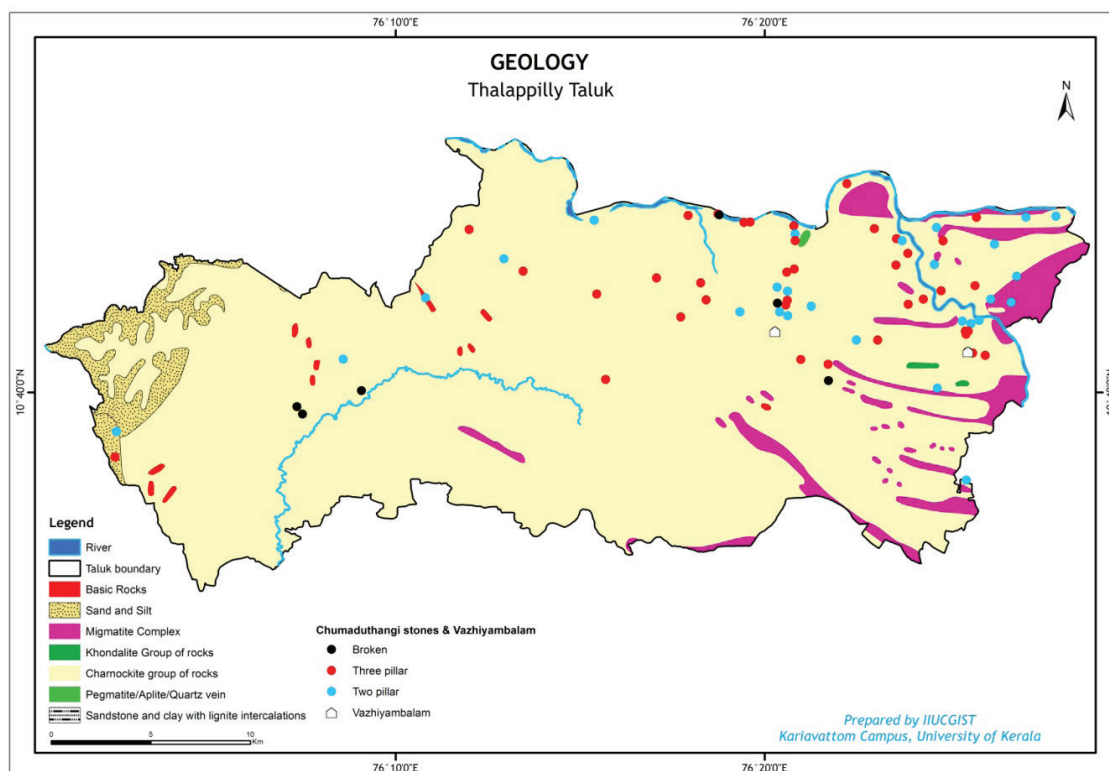
Figure 13. Geology map of Thalappilly Taluk

The *Chumaduthangi* are distributed all over the Thalappilly taluk (Table 1). The Charnockite group of rocks are abundant in the present study area (Fig. 13) and majority of *Chumaduthangi* are made of the same. *Chumaduthangi* are also present over the other geological formations such as Sand and Silt, Migmatite complex Permatite/Aplite/Quartz vein and basic rocks. It is clear that the maximum numbers of *Chumaduthangi* are located in the gravelly clay and loam types of soil (Fig. 14). Some are present in the clay and sandy soils. Thalappilly taluk falls in low land, midland and high land area (Soman 2002). They are mainly distributed over the lowland (10-300m above MSL) and midland (300-600m above MSL) region and a few are noticed in highland (600-1800m above MSL) area (Fig. 15).

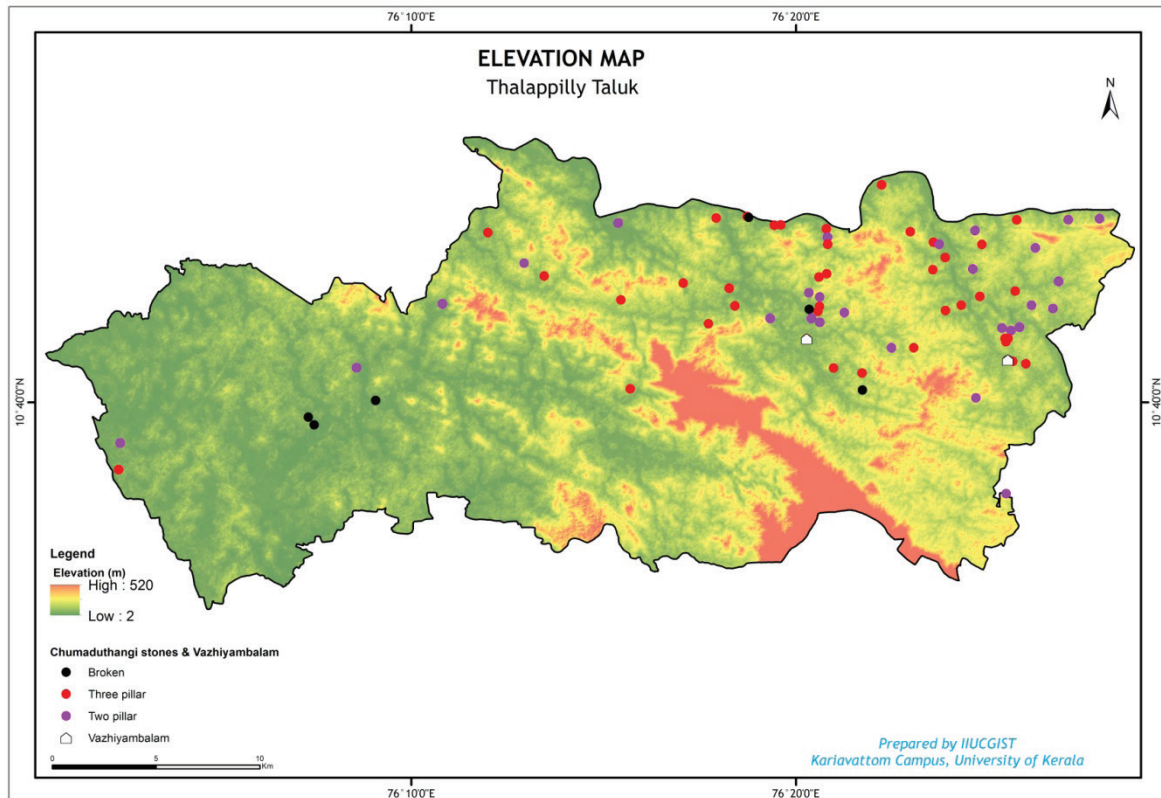
Figure 15. Elevation map of Thalappilly Taluk
