Śarda Temple: A Legacy of the Stone Temples of Kashmir

JUNAID AHMAD AND ABDUL SAMAD

The current paper deals with an archaeological site in Sharda village of Neelum Valley in Azad Jammu and Kashmir, Pakistan. It is known with different identities however its general features are close to the style of stone temples in Kashmir. The structural remains are on the verge of extinction due to weathering and neglect. The paper tries to document the very remains on the basis of their architectural features and location in the contemporary landscape to bring it into the notice of the scholars.

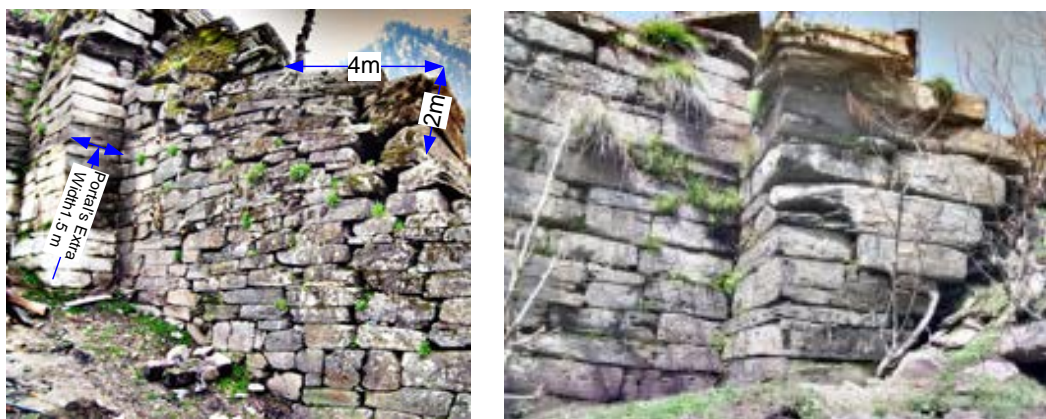
Figure 2: Staircase joining the portal's podium. A view of northern and southern faces respectively.

foundations of the main structure about 2 m from the south-western corner of the main court. On both sides, this portal is 1.5 m broader than the width of the staircases. The portal structure resting above it is of same level as that of the court (Figure 2).

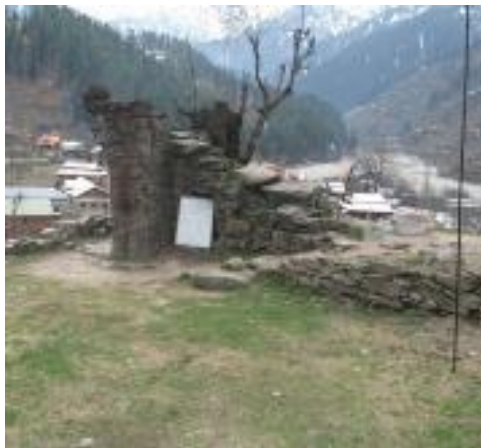
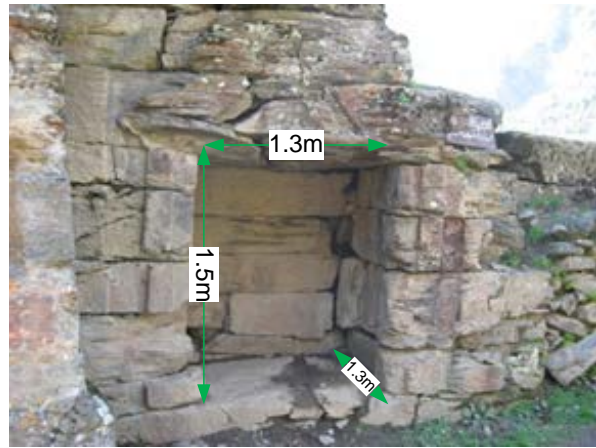
Figure 6. Western Wall

The western wall is mostly covered with the entrance portal (Figure 7-a). Including half of the entrance and southern corner of this wall as well as coping of the northern side is missing. The southern corner of the portal area deludes for south-western corner of the

To the 50 cm north from the joint of portal and northern segment of western wall, is a 1.3 m deep niche (Figure 7-b). It is 1.3 m wide and 1.5 m high. There is a stone topping it. The upper portion from outside is provided with a false pyramid like geometrical motif.

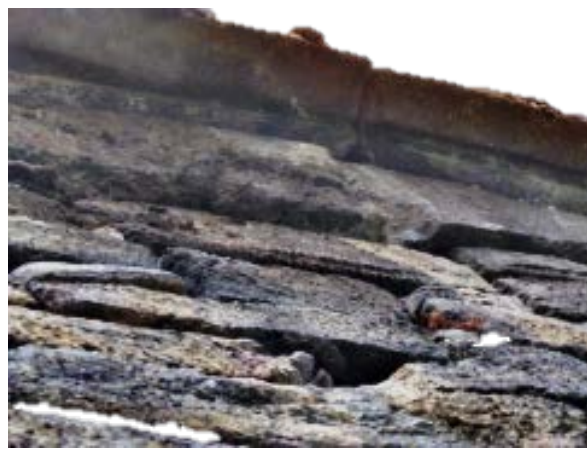
Figure 7. Coping in the Northern Wall

Some places on this wall are provided with coping. The coping was possibly introduced around the entire enclosure wall (Figure 8). There are some such remains in the northern wall. These extend to a length of about 3 m in the eastern corner of this wall and then it is followed by continuations of a ruined superstructure. This coping is projected above the wall making an eave. From outside this coping is has a small groove beneath the eave, possibly to prevent the rain water from getting stuck with the wall (Fig).

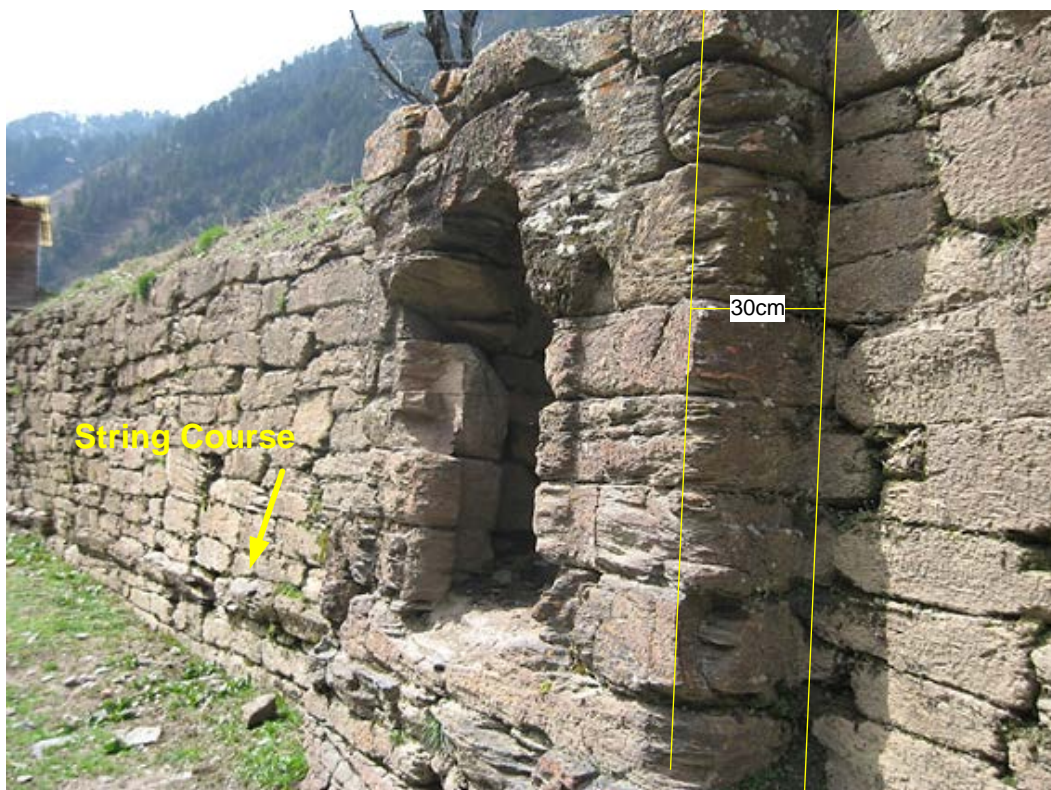
Figure 8. Northern wall and the niche

The wall above the level of the quadrangle is not different outside view. However from inside, there is a deep niche in its middle, fronting the main sanctuary (Figure 9). It is located just above the dado level. It is projected

about 30 cm out into the court. However being at a little raised level it is supported with small sloped projection like that of a common type for the balcony. Stein (1900: 283) says about the geometrical design of this niche. It is nearly a cubical of 1.25 X 1.18 X 1.25 m from inside. It once contained two small *Linghams* (Stein 1900: 283), as it looks that it was originally built for receiving such cult. The opening wall of the niche is projected in a way that it could be easily accessible for the worshippers. Opening is little designed and once had same pyramidal panelling (Stein 1900: 283) however they are not that clear now.

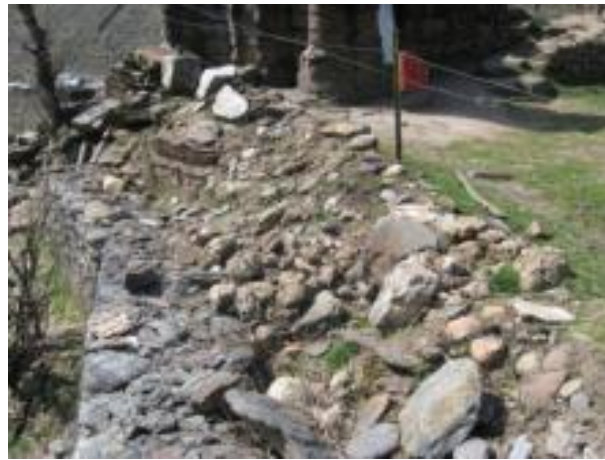
Figure 10. Reinforcements for southern wall

The eastern corner has left with some part of it. The stones of this wall can be seen dispersed on its place as well as in the strata of the steep below. There are wild olive plants found abundantly on this steep. These plants have destroyed by moving the existing foundation stones. However, currently, they are strengthening the remaining structure by minimising the erosion.

The remains of, once a niche in its midst, are obvious in the form of the fragmentary traces of *kanjur* stones. They are dispersed on the surface where a modern strengthening wall is built on

the same place. Such walls are currently built in the gapes and crevasses are reinforced with meshing of steel wires.

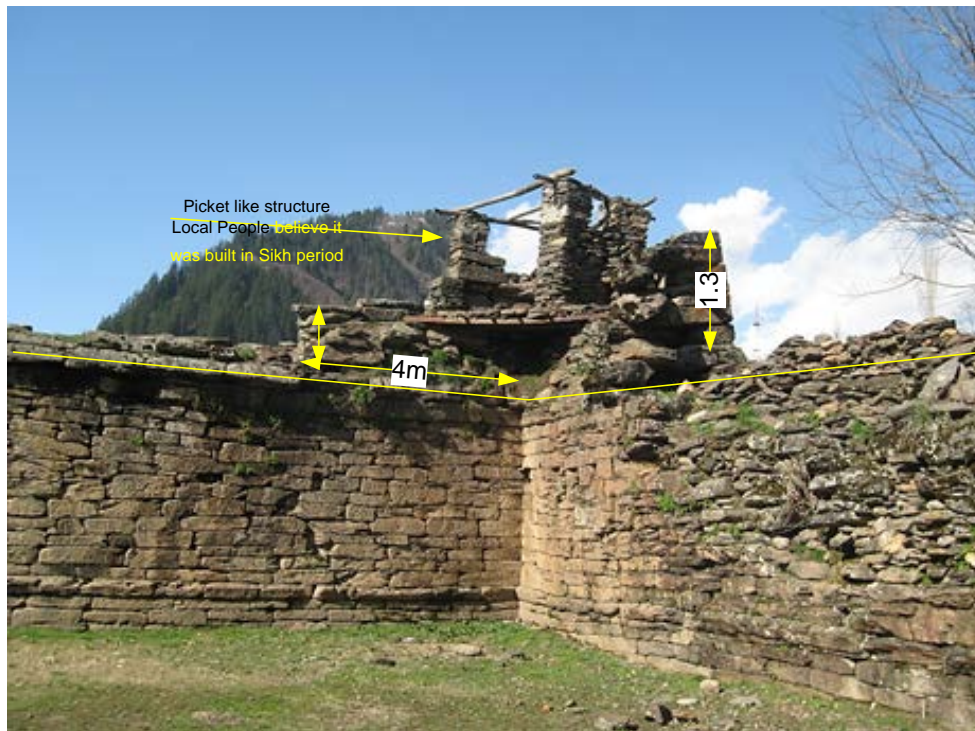
Figure 11. Observation post in the north-eastern corner (possibly Sikh Period). Old wall continuation to its east. (Encircled)

Above the enclosure wall in the eastern side of the quadrangle, there is a continuation of the wall above its level of coping. It is not only true for the eastern wall but also extends to about 4 m into the northern wall. In the eastern wall it raises as a pediment with 1.3 m height at its apex. However it is not finished at the top. It looks like it is decayed (Figure 12).

It is a 60 cm thick stone wall positioned on the outer side of the all below.

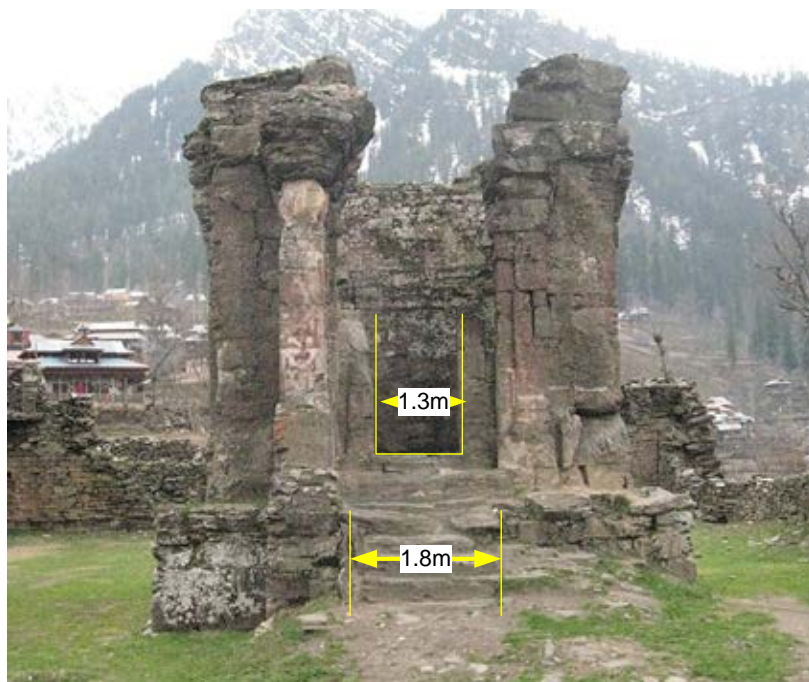
Figure 13. The entrance to the sanctuary

To the western side of this plinth, a small humble staircase is attached to ease the only access in the sanctuary (Figure 14). It is 1.85 m wide and each step is about 60 cm flat and has same height. Both sides of the staircase are provided with a covering by using a long stone of about 0.5 m width.

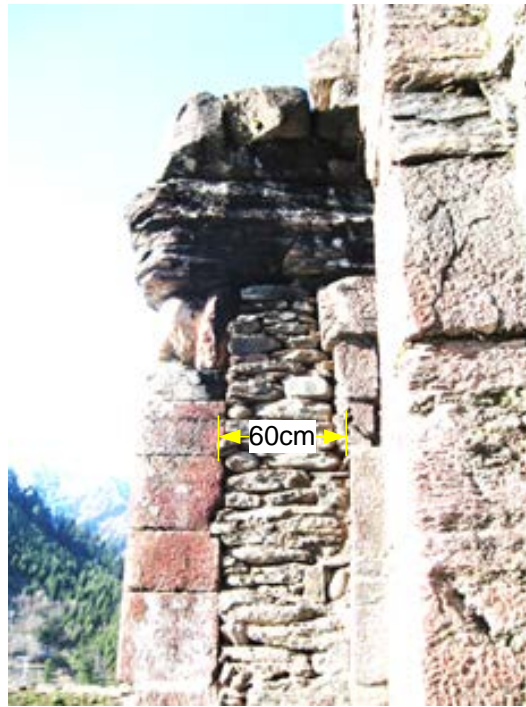
Figure 14. The remaining pillar of the canopy to the door from southern side in front of door. These repairs have cement used in some instances.

The door has fronted with a kind of canopy to cover the small flight of steps, of which only pillars in the northern side can be seen. The other side is lacking with such remains. There is small gap (about 60 cm) between the pillar at the end and the pillar attached to the sanctuary at front. Currently it is filled with small chips, but it yet clear that originally it was open (Figure 15).

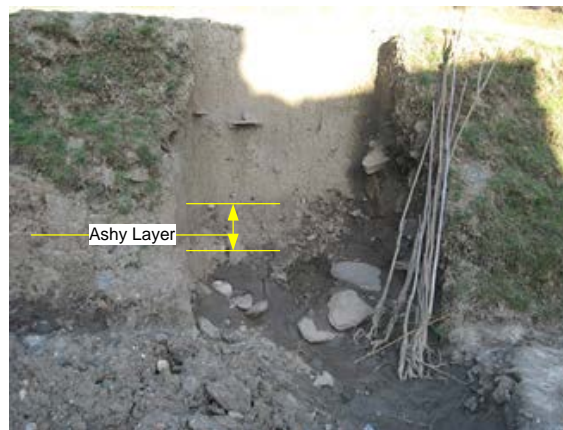
Figure 15. Trial Trench in a farm to the east of the site (

On the course of the archaeological survey of Kashmir, a team of archaeologists from Taxila Institute of Asian Civilization (TIAC), Quaid-i-Azam University, Islamabad, also documented the site. A trial trench was laid out, located 10 m east of the eastern wall in a farm. An elaborate ashy layer is clearly visible along with concentration of the potsherds. The report of the exploration will shed light on the site (Figure 16).

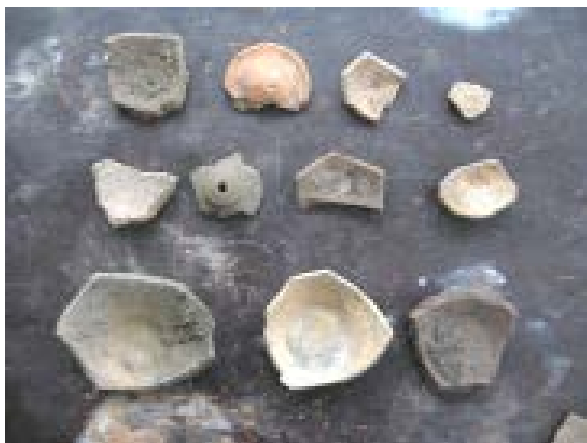
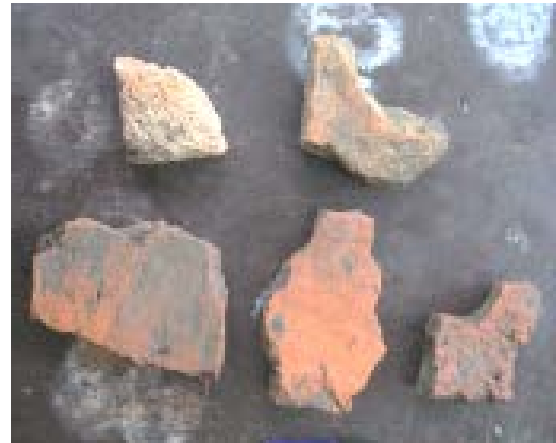
Figure 16. Terracotta from the Site

The cultural material that can be found abundantly in the whole area is the pottery shards (Figure 17). They can be found in near surroundings of the temple and temple itself. Apart from conventional offering bowls, pieces of rough textured bricks can also be found.

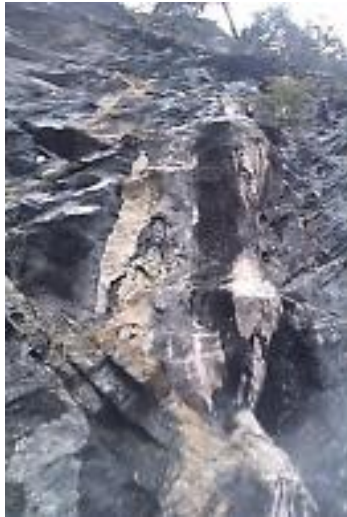
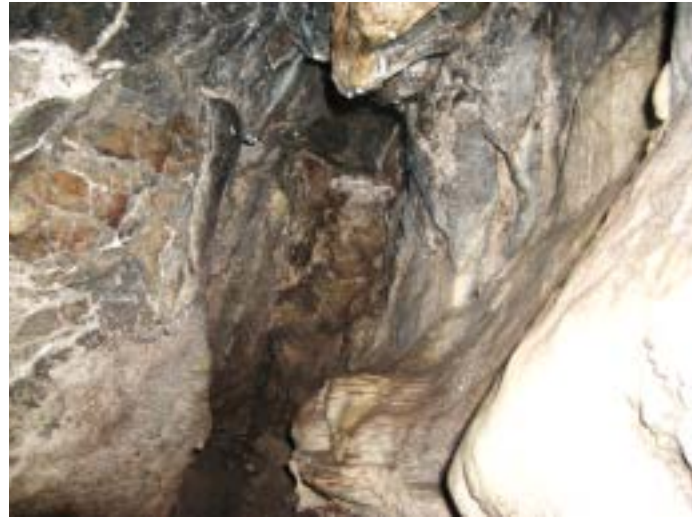
Figure 17. a. Kiśan Gatī

b. Cave in Kiśan Gatī (Inner View)

the surface of the boulder, traces of stucco-like material can be observed. The word “OOM” is written in Śārādā script that can be visualized as dim lining in pinkish red pigments. In addition a Swāstīka can be seen (Figure 18-a). Stein (1900) explains the Sharda Muhatmya’s story that a muni, Muni Śandliya (Kumari 1988) saw here a Gneśa figure.

At the head of this boulder, a cave is located in a position that it is hard to get in there. It’s a natural cave for which local peoples’ referral is quiet often. They believe it is a sacred Hindu Site where they used to visit before partition. Accordingly, many cults are located in a square room. On the contrary, the cave looks like a natural phenomenon. It is irregular in symmetry (Figure 18-b). The upper portion of the cave is littered with stalactites posing fearing ghostly effects which possibly mystified it.

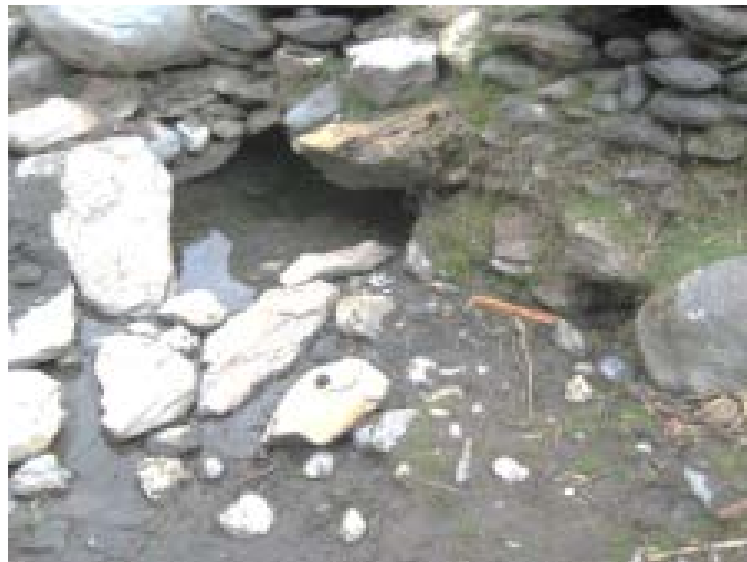
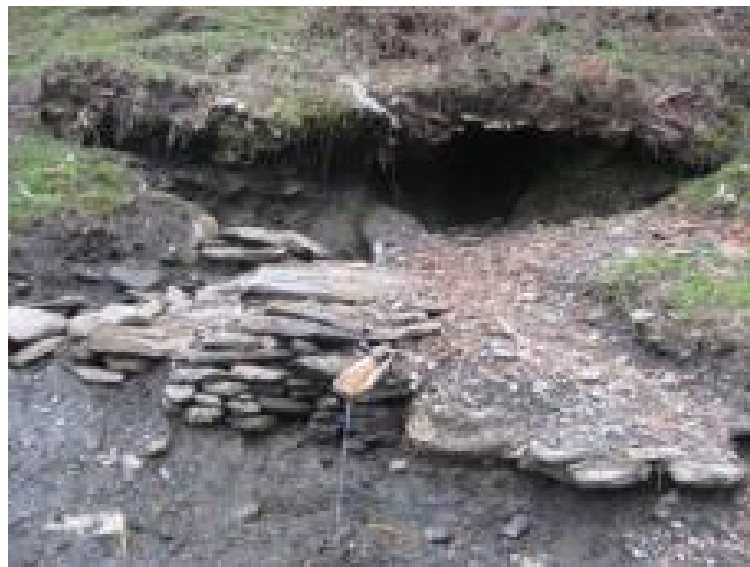
Figure 18. Two water sources along the Sharda Nar a. along the bank and b. little above the stream.

Water sources are crucial to any Hindu Temple and particularly in Kashmir. Qadir (1993) allotted the name of Amara Kund to the water source of this temple. There are three main water sources while walking along the Sharda *Nar*, at about a furlong upstream is a waters spring (Figure 19-a). Moving upward, there is another spring (Figure 19-b). From this spring water supply schemes are leading to the inhabited area around the Sharda Temple.
